# **Scientific Studies on Conservation for Üzümlü Church and its wall paintings in Cappadocia, Turkey**

**Vol. 1 : Annual report on the activities in 2014**

**University of Tsukuba  
2014**

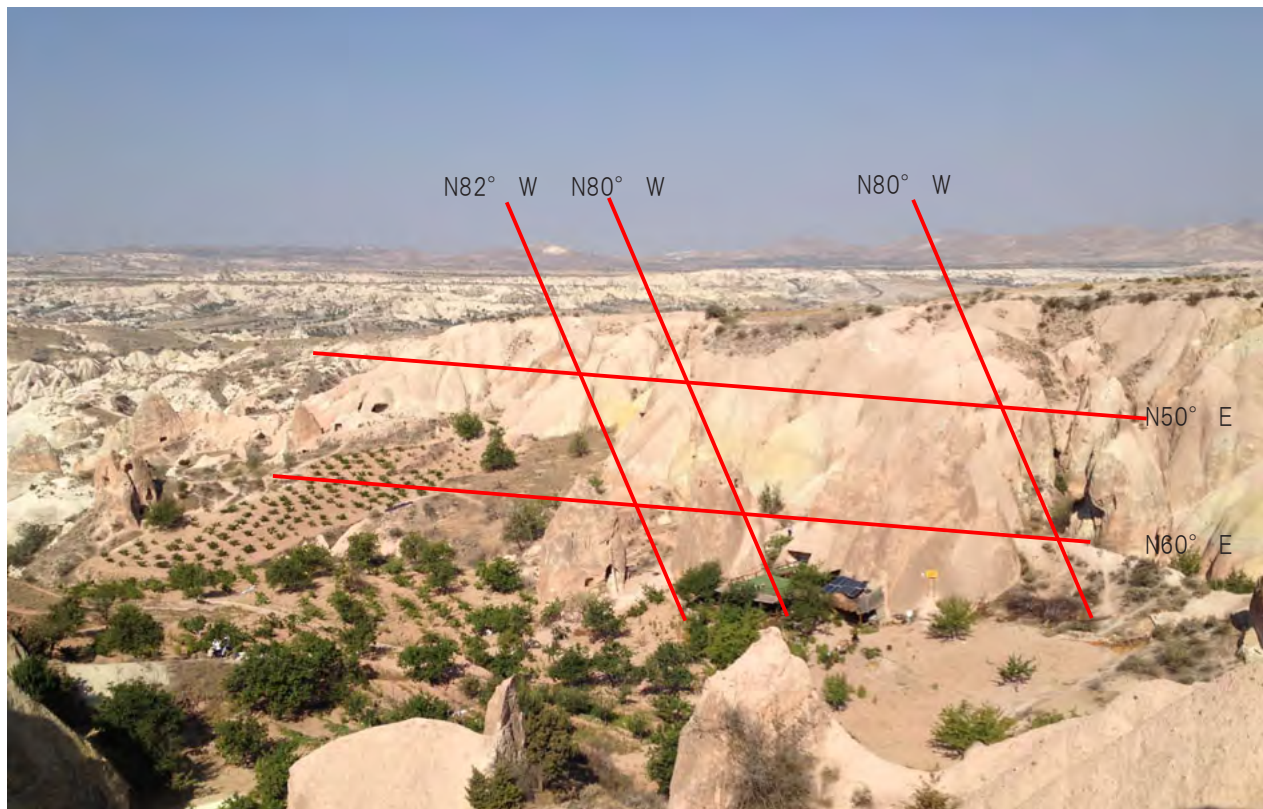
Figure 4. the lineament conditions around church

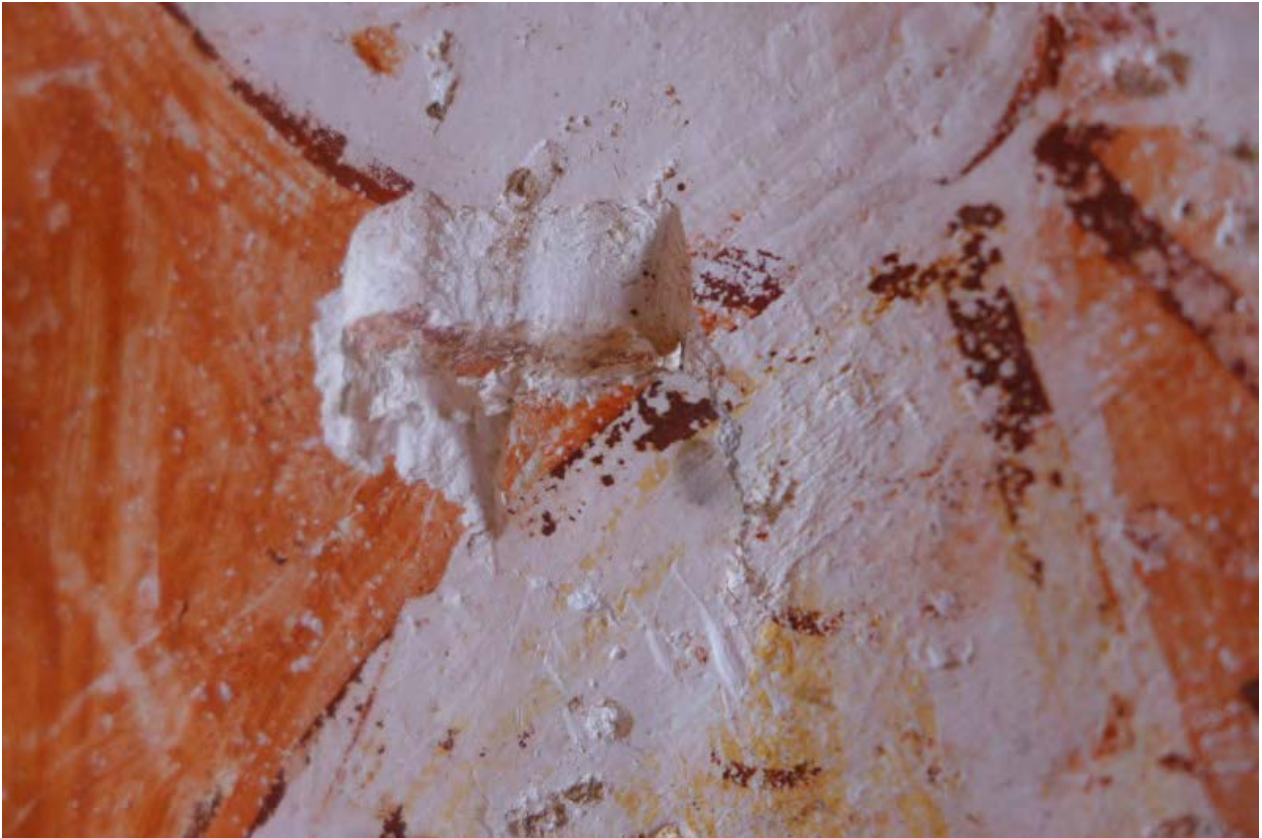
Figure 8. Where damaged through impact, the plaster appears fractured but compressed, suggesting that it is quite a soft material

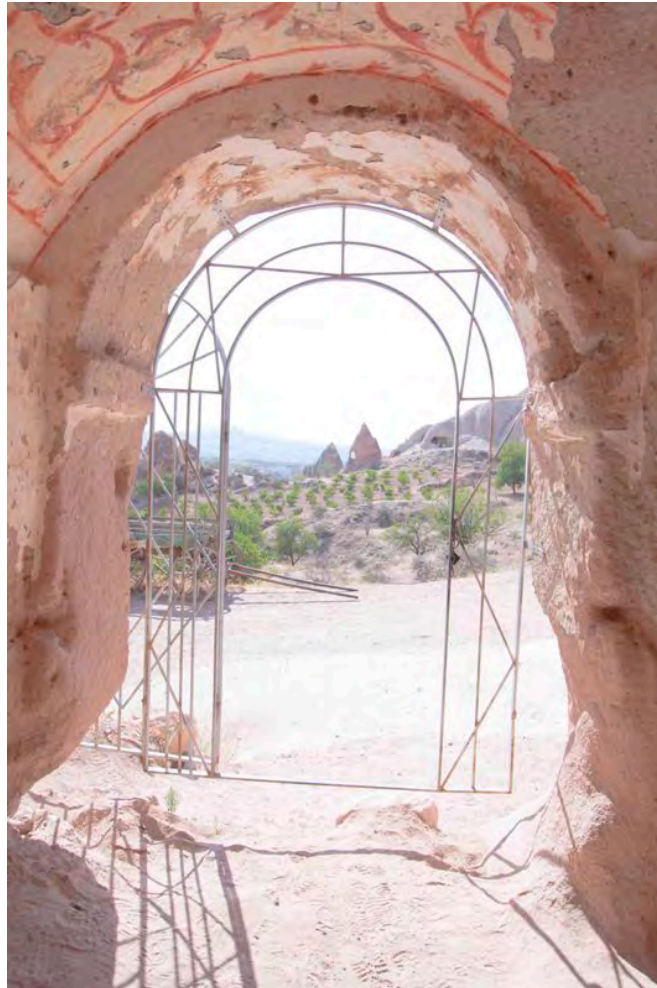
Figure 13. Metal door which secures the entrance to the church

Mekanik hareketle devam eden hasarı büyük olasılıkla, tırmanarak girmenin kolay olduğu, kiliseye girişi güvenlik altına alan, kötü takılmış kilit kolaylaştırıyor (Resim 13). Kapıların geniş aralıklı metal kalıpları hayvanların kiliseye girmesini engelleyemiyor olmasına rağmen son zamanlarda yerleşim belirtileri gözlenmedi. Buna karşın, kilisenin genelde kilitli olduğu görülüyor. Açık olduğu zamanlarda ise ziyaretler, daha fazla vandalizm ve hasarı artıracak şekilde refakatsiz ve denetimsiz olarak gerçekleşiyor (bölgedeki diğer pek çok kilisede olduğu gibi).

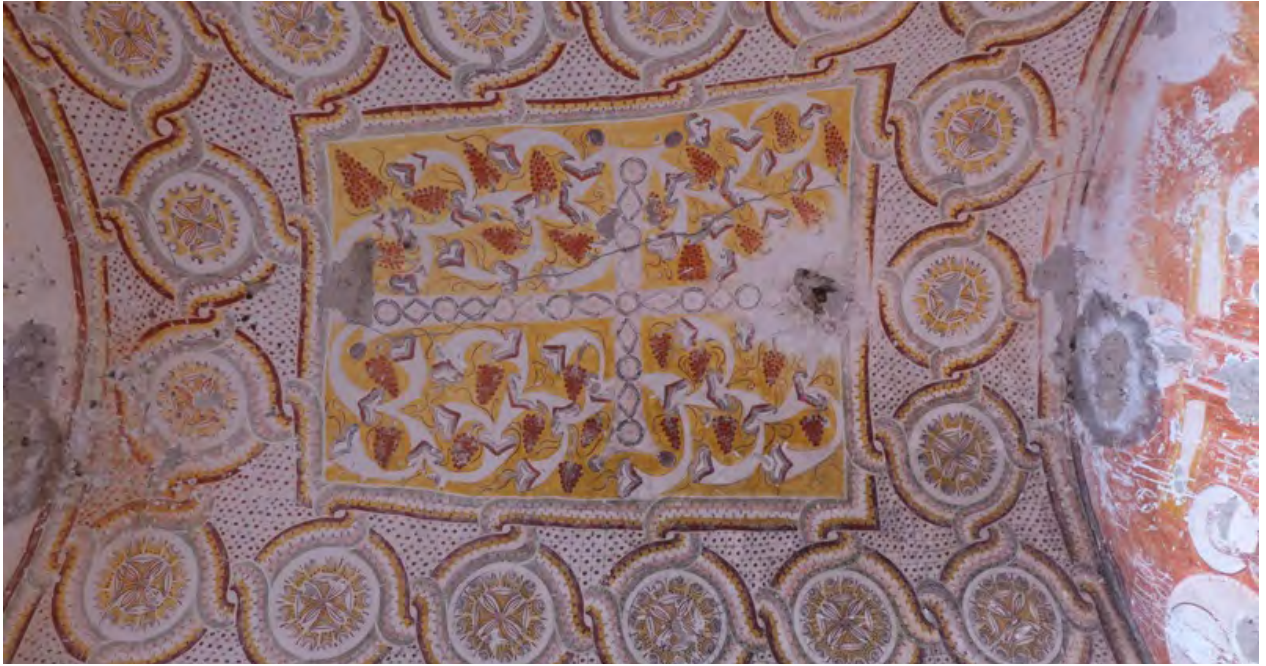
Figure 14. A structural crack can be seen running through the plaster and paint layers on the ceiling of Chamber 2, from east to west

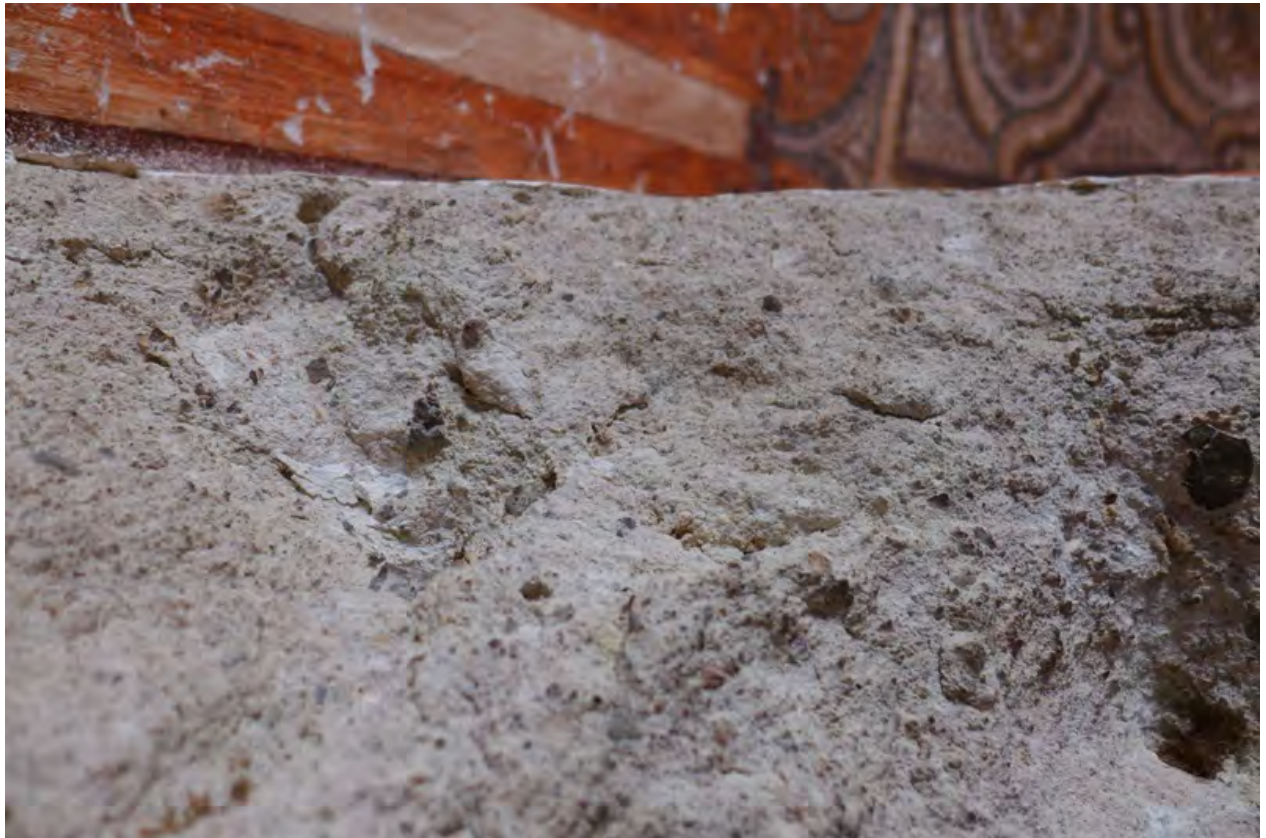
Figure 15. Spalling of the stone was observed in some areas

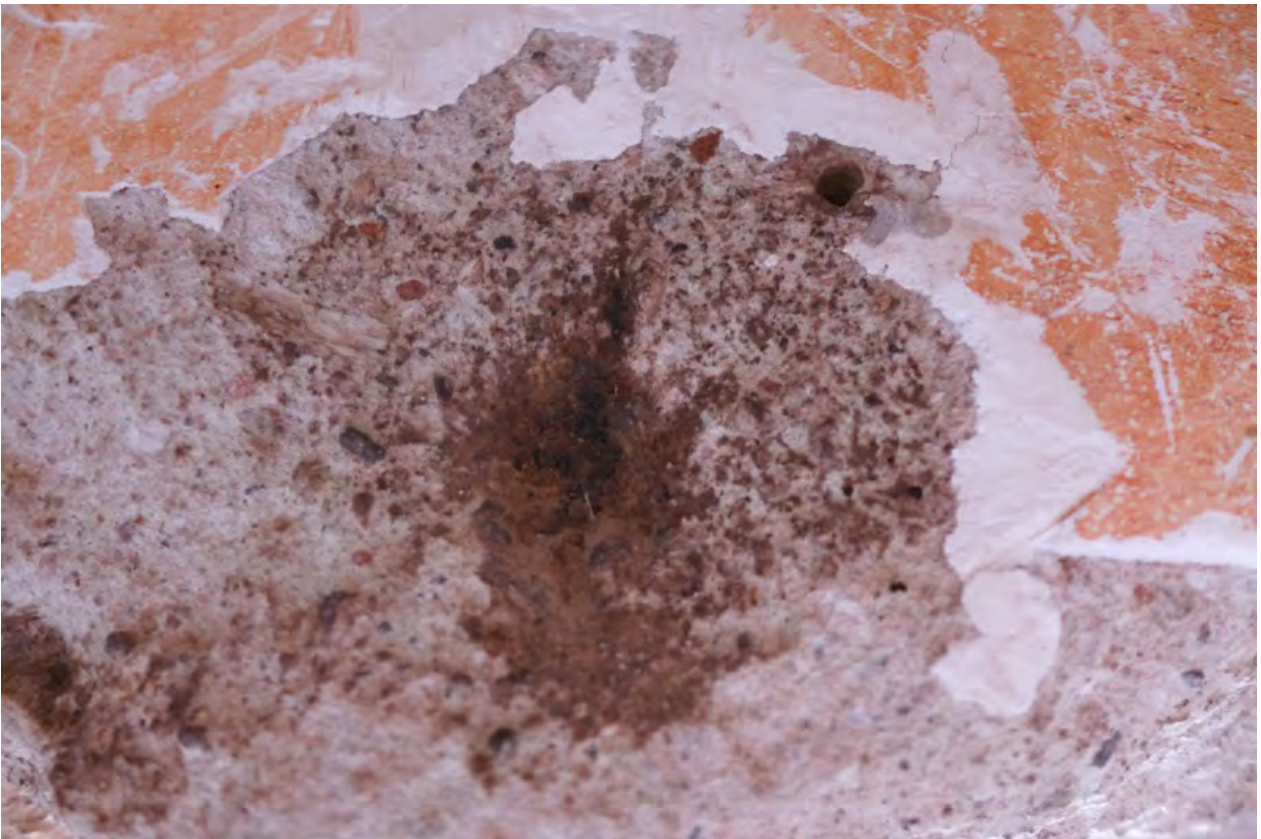
Taş alt tabakanın ortaya çıktığı bazı hasarlı yerlerde koyu kahverengi-siyahımsı bir madde birikmiştir (Resim 16). Bu maddenin kökeni ve yapısı şu an için belirsizdir ancak biyolojik kökenli olduğu varsayımında bulunmaktadır.

Figure 16. A blackish brown material is deposited in some areas of exposed stone substrate. This may have a biological origin

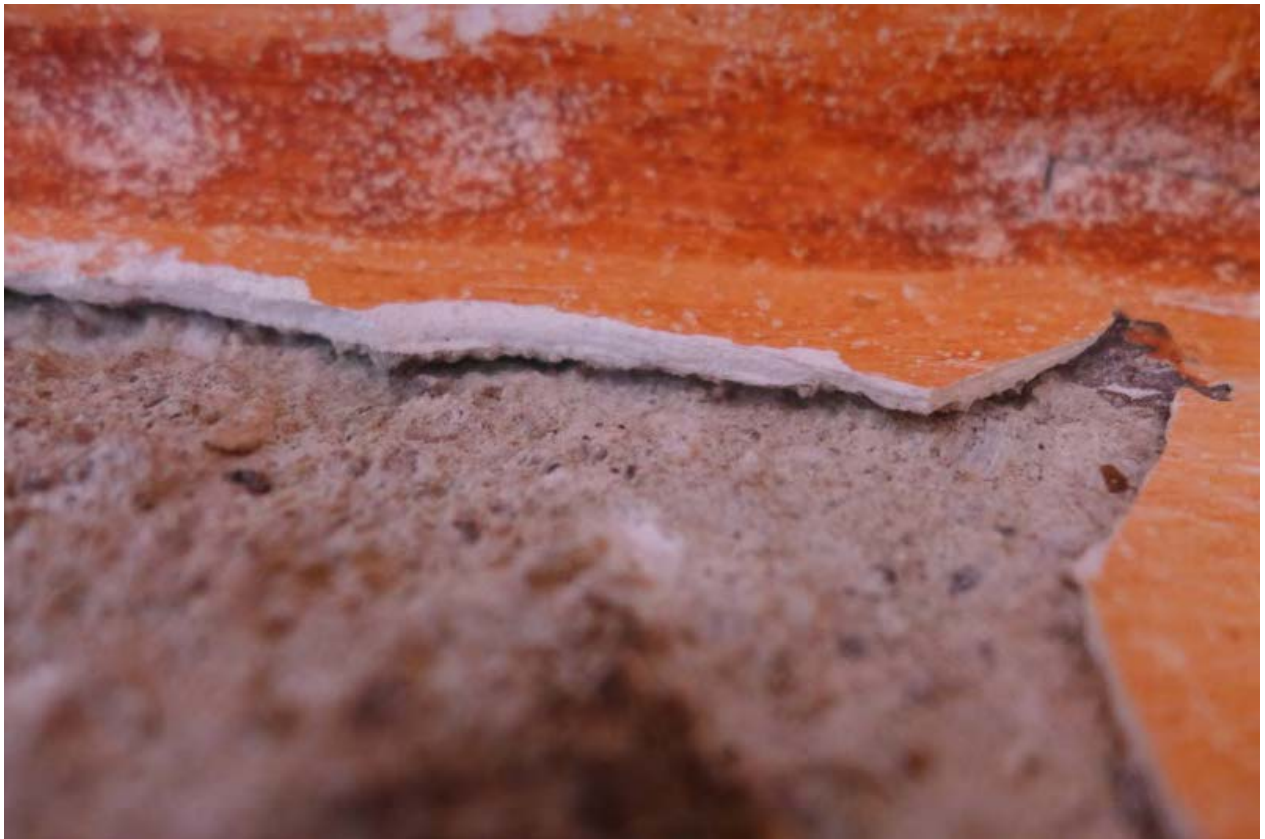
Figure 17. Area of delamination associated with mechanical damage

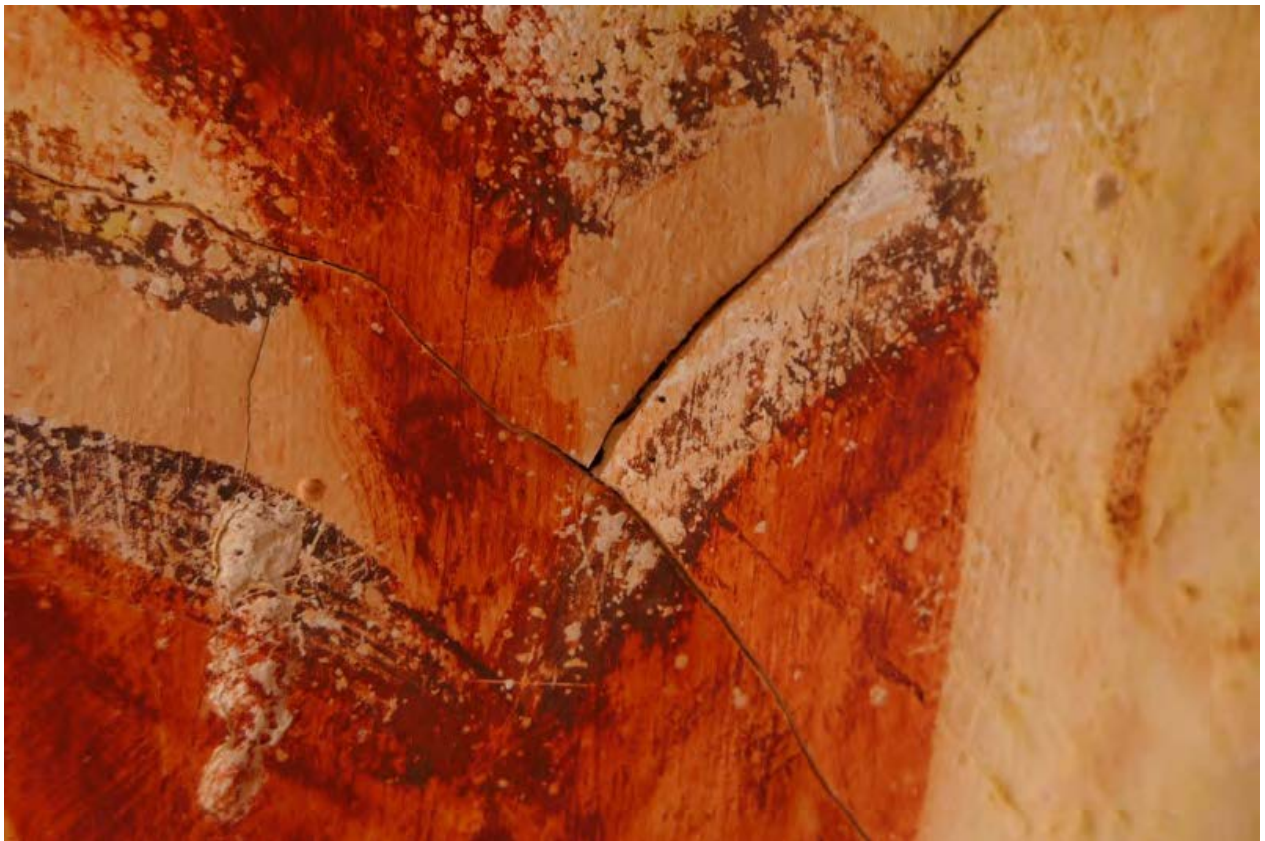
Figure 18. Area of delamination associated with structural cracking

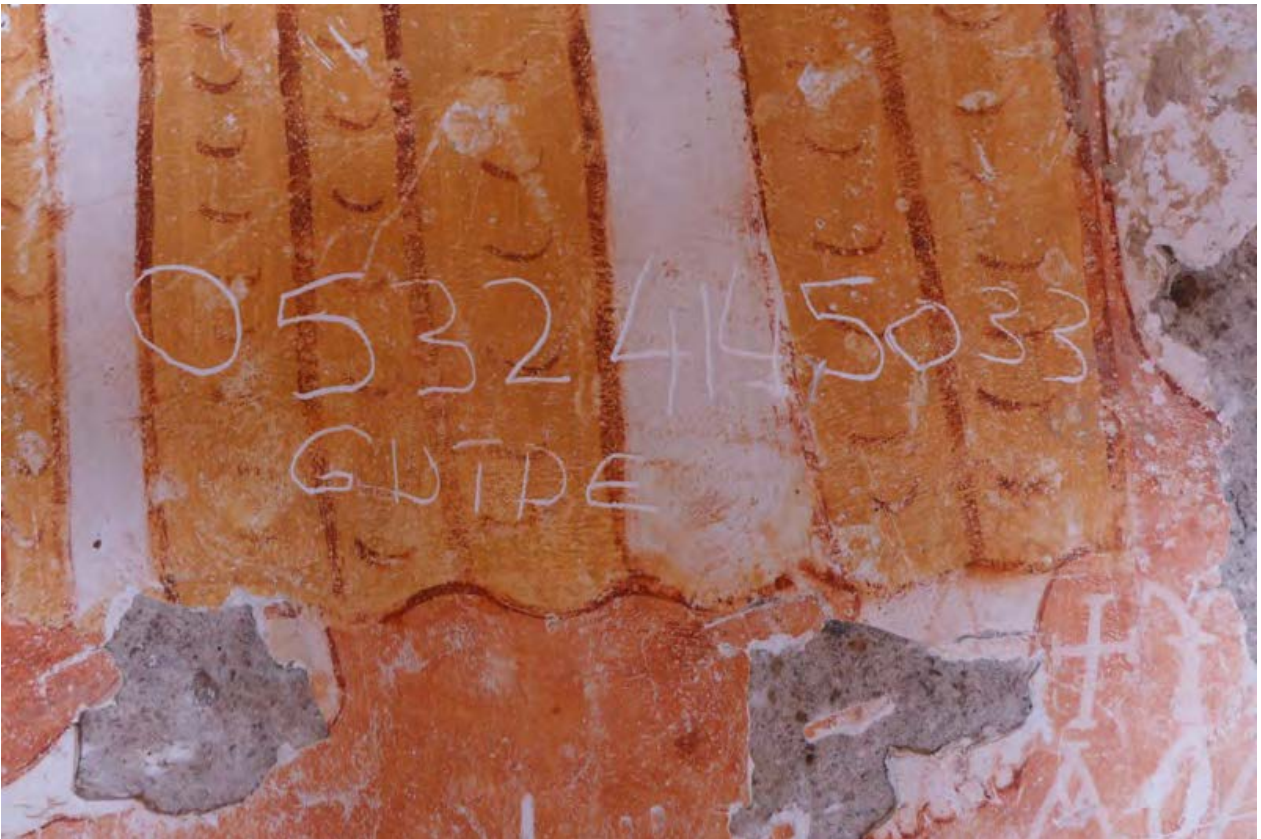
Figure 19. Modern graffiti

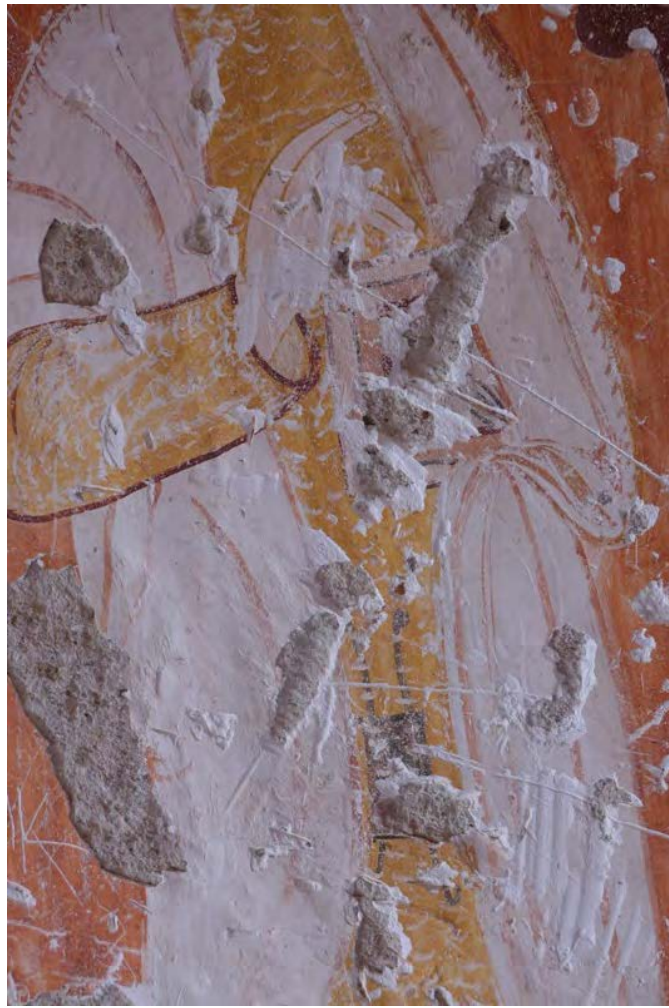
Figure 23. Damage caused by gouging

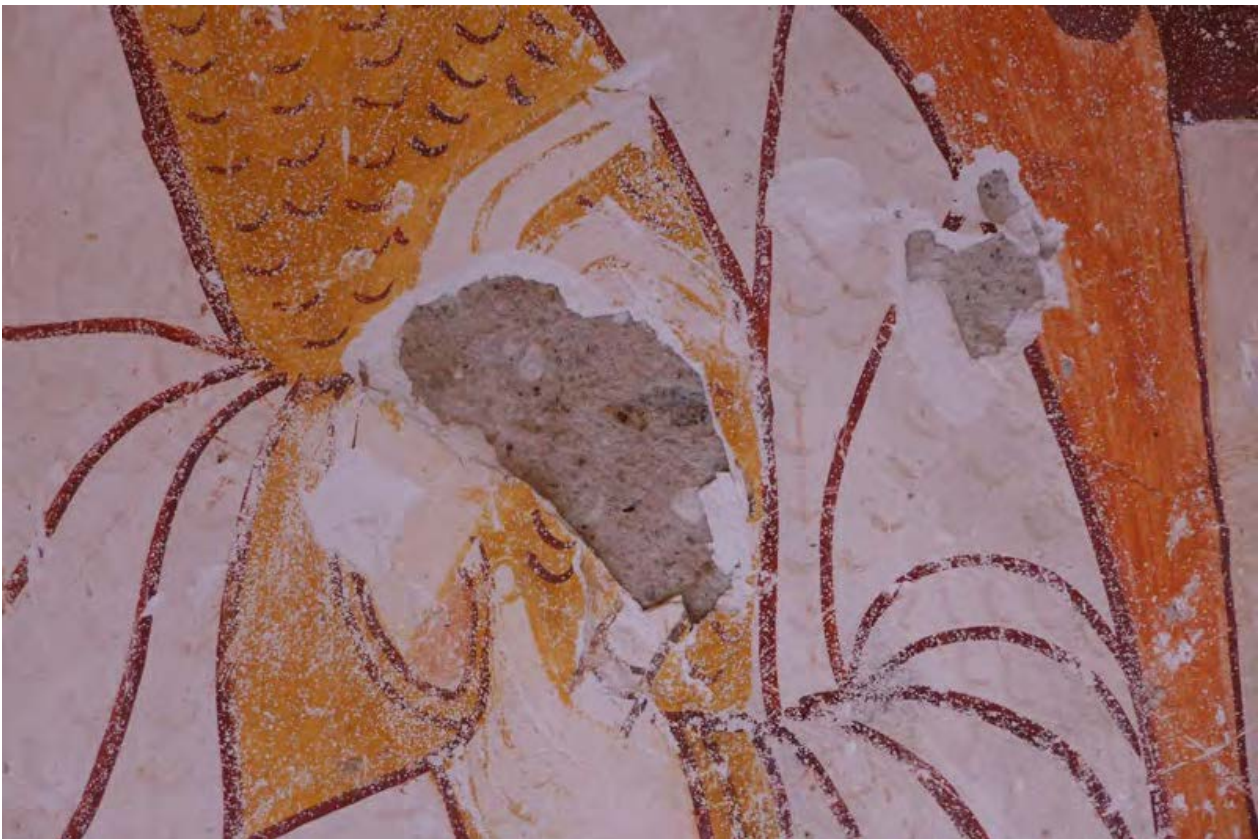
Figure 24. Damage caused by impact

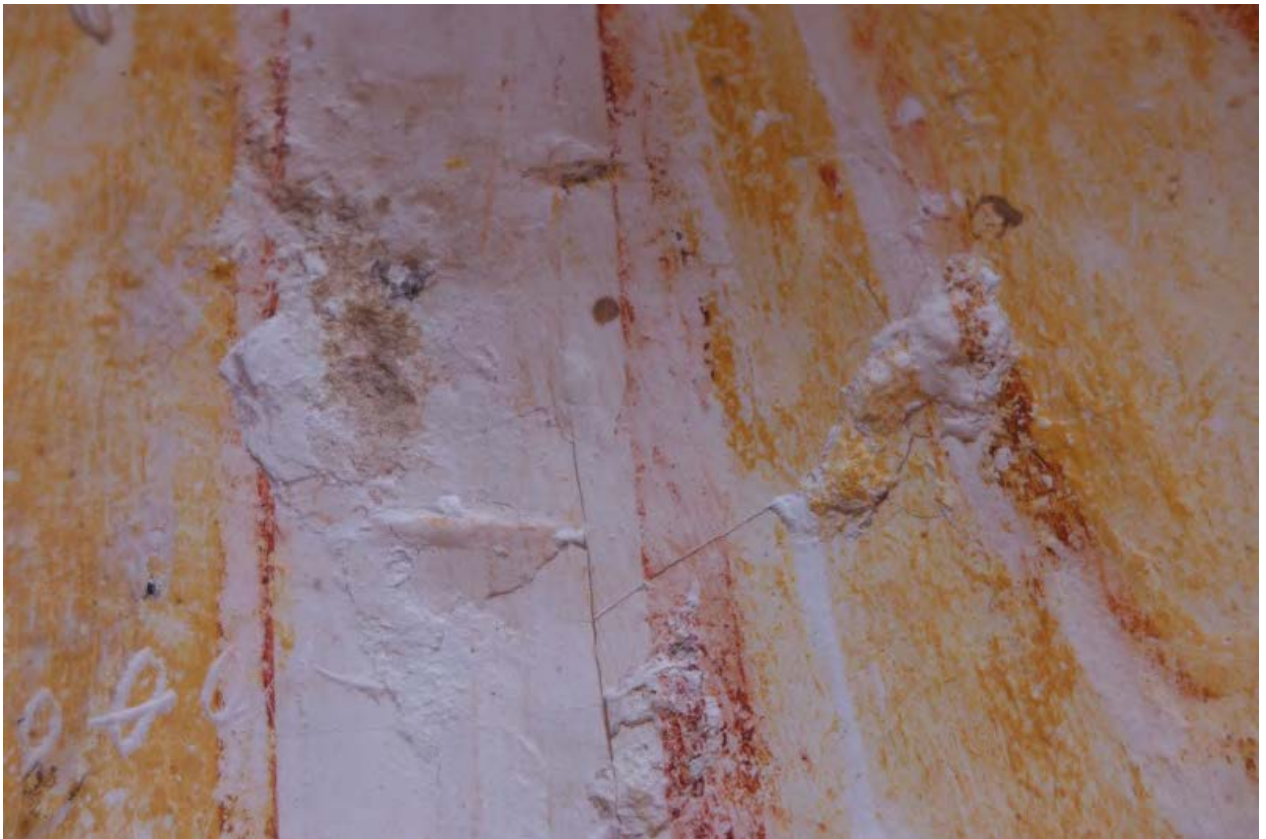
Figure 25. The painting stratigraphy has remained intact despite impact damage

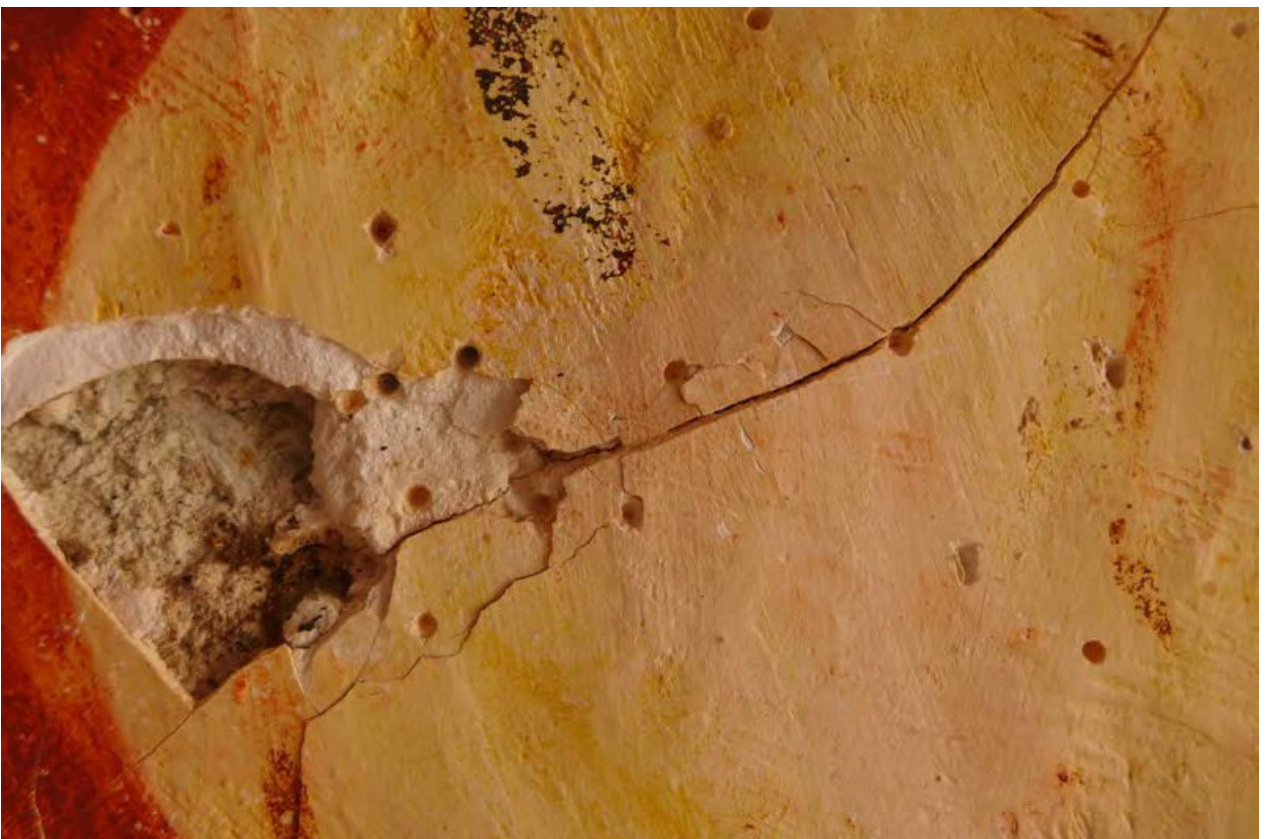
Figure 26. Small and homogenous holes were observed in the plaster layer. Their origin is unknown

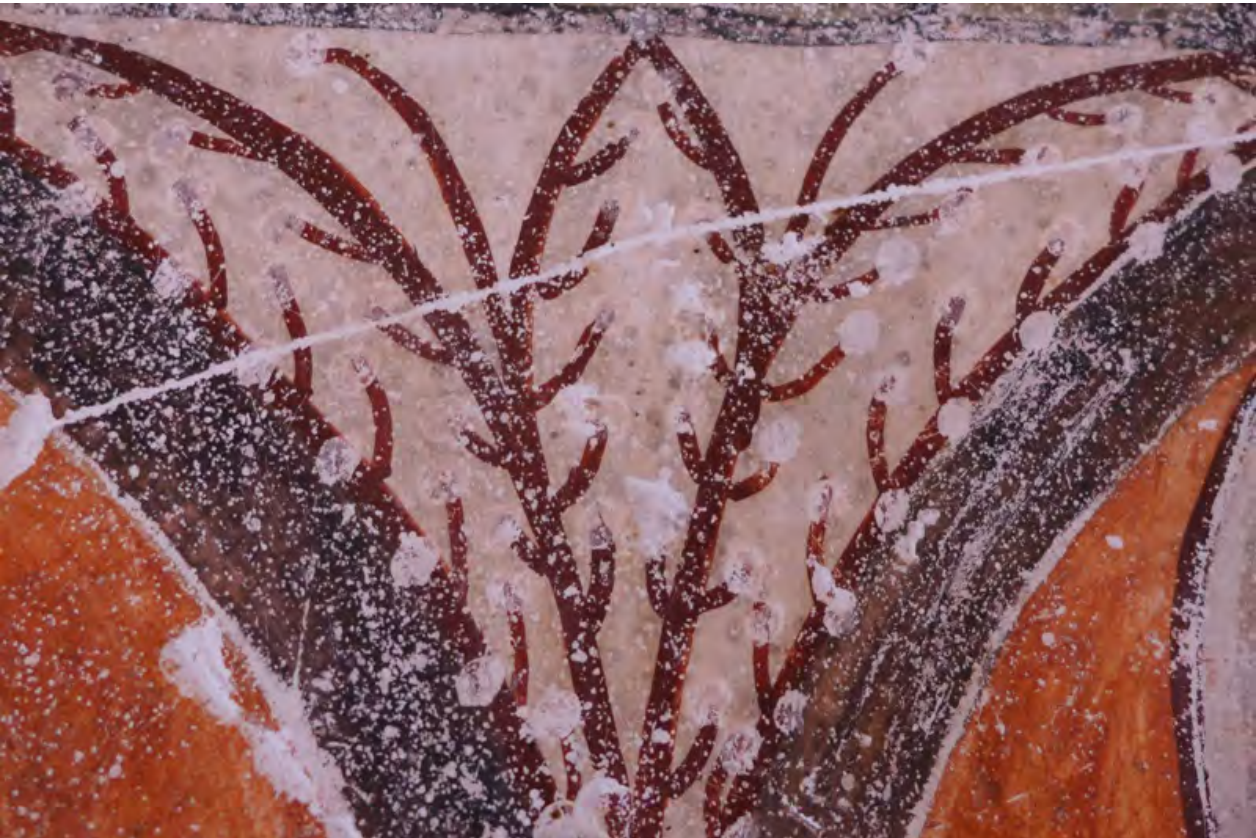
Figure 35. Circular microlosses of the paint layer, and black spotting in adjacent areas
