# **Scientific Studies on Conservation for Üzümlü Church and its wall paintings in Cappadocia, Turkey**

**Vol. 1 : Annual report on the activities in 2014**

**University of Tsukuba  
2014**

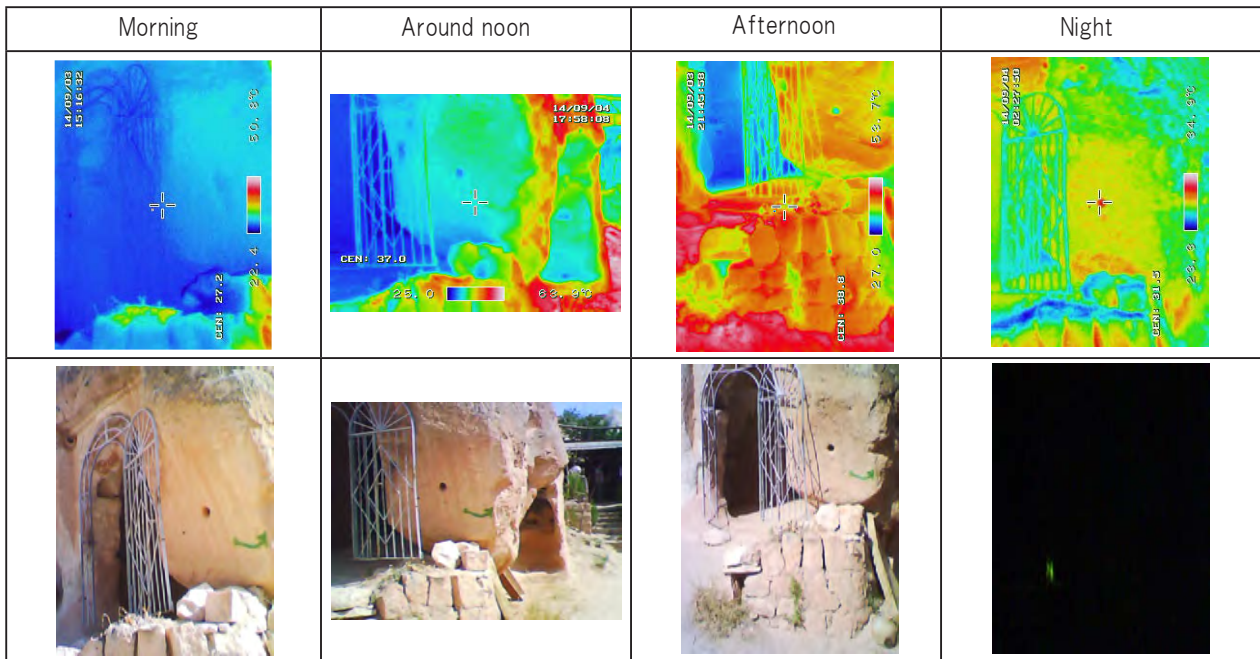
Figure 7. Thermography of the entrance (southwest side)

Saha araştırması sırasında, sabah (9:00), öğle, öğleden sonra (15:30) ve gece (20:00) termografi çekildi. Bu fotoğraflardan bazıları Şekil 7, 8 ve 9'da gösterilmektedir. Gölgedeki sıcaklık dış ortam sıcaklığıyla neredeyse aynı kalırken, kilisenin güneşli tarafında yüzey sıcaklığı yaklaşık 50 °C'ye yükseldi. Güneşli tarafın yüzeyinde büyük bir günlük sıcaklık farkı olduğu teyit edildi.

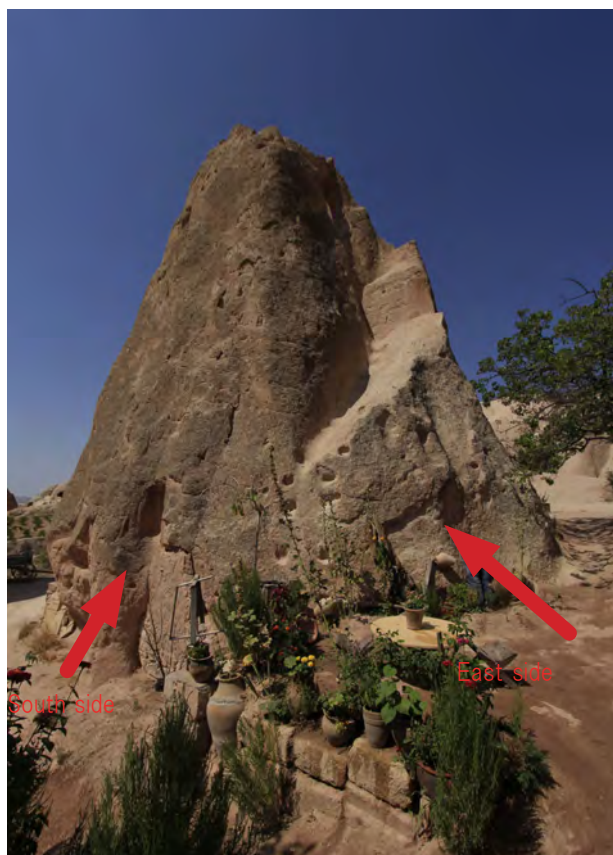
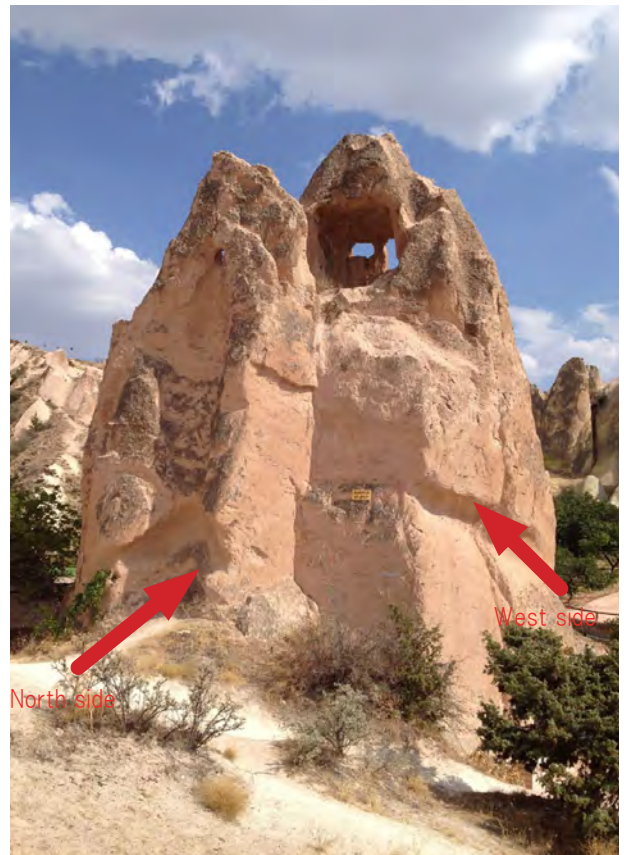
Figure 3. each side conditions of the church

As a result, we confirmed that the north side was higher and the west side was lower in intensity than the other sides. However, each side was highly variable in intensity. Because the test points were chosen randomly, it was not possible to grasp the influence of the gravel particles inside the foundation, tuff rock. It was not clear which side suffered heavier weathering conditions. In order to assess this in detail, further in-situ testing is required.

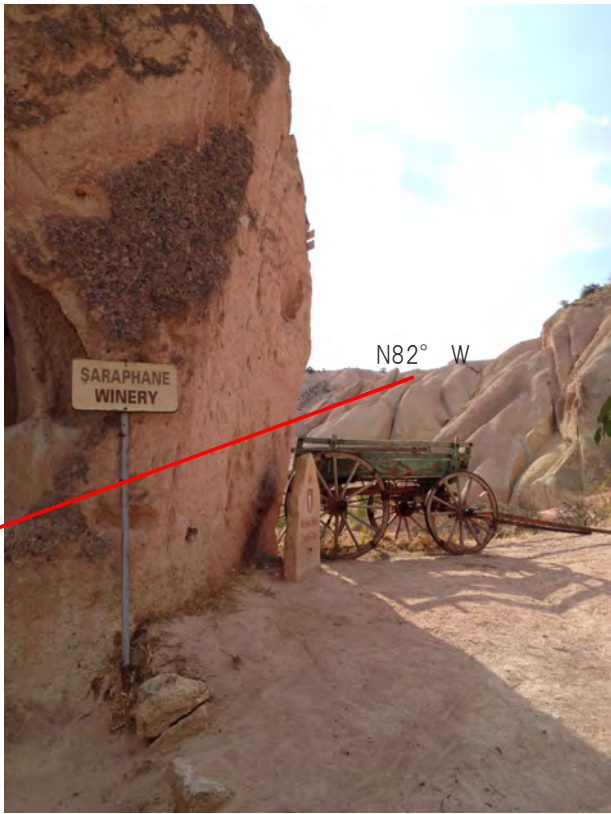
Figure 5. the rock surface caused by fault (winery)

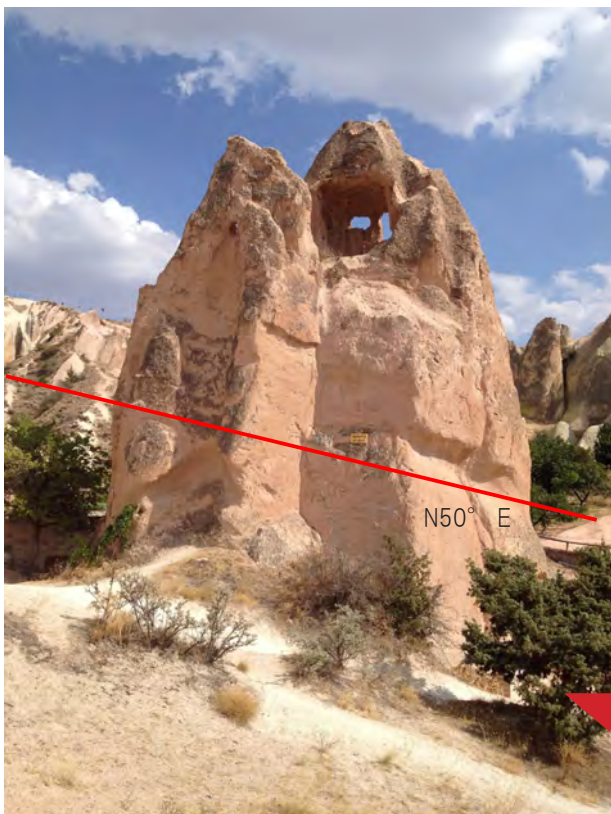
Figure 7. the rock surface caused by fault (north side of church)

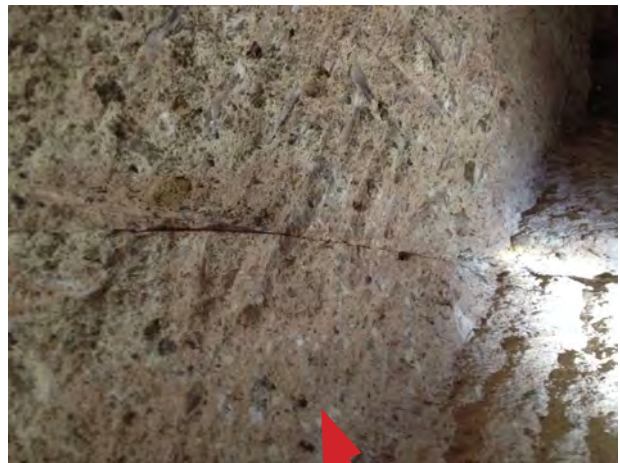
In fact, we have confirmed that a large crack passes completely through to the other side of the church's foundation, and also detected the presence of free lime crystals which formed inside the crack due to water flow.

The crack passes completely through to the other side of the church's foundation, and free lime detected inside of the crack indicates water flow.

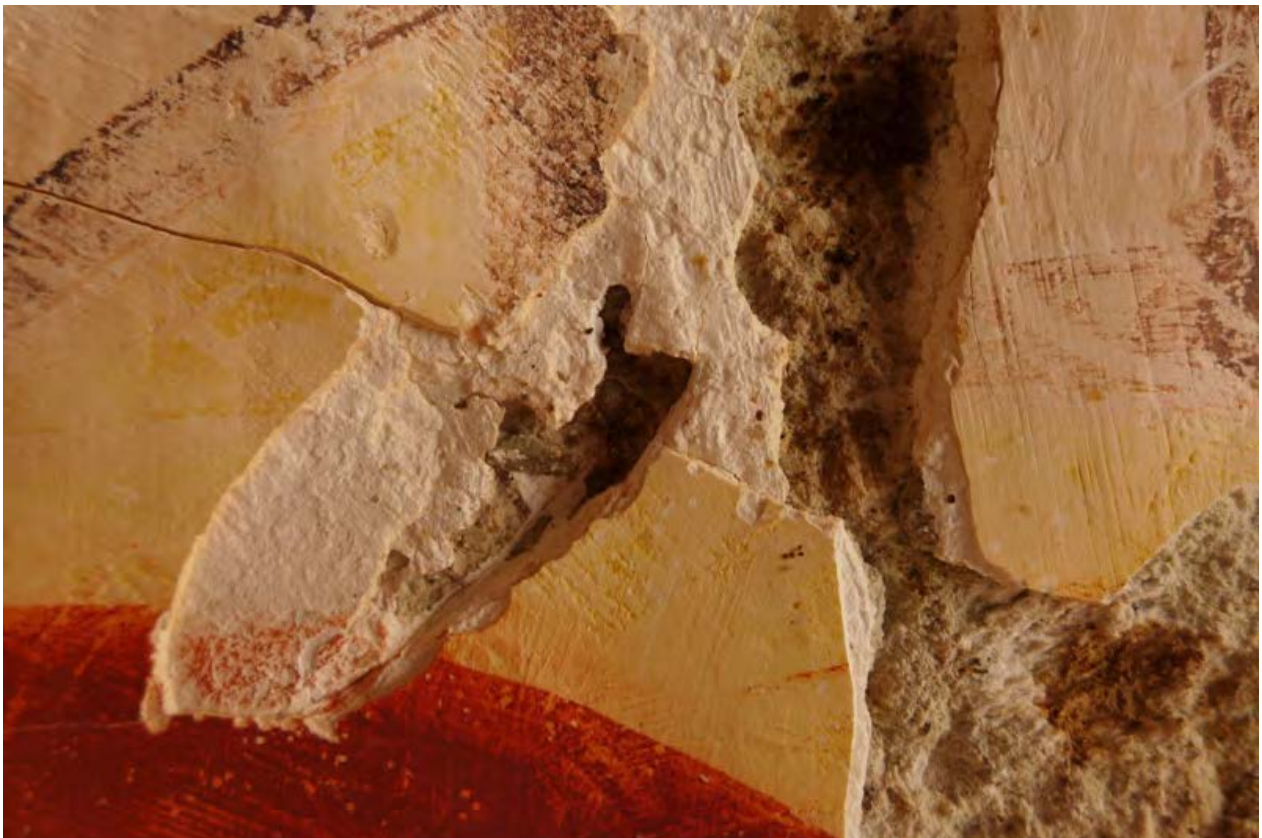
A single very thin (~2-5 mm) and bright white layer of plaster covers the walls in Chambers 1-3 (fig. 7). Generally it appears to contain very little aggregate, though in some areas sandy inclusions were observed (mainly in the dado level plaster layers and in Chamber 1). However, this sandy material may have originated from the stone itself, and been drawn into the plaster during application, rather than being a deliberate addition to the mix. This question could perhaps be better resolved by further examination.

A very thin ground (~1-2 mm) of what appears to be similar material was applied on top of the plaster layer. This layer is bright white, but sometimes appears to have a slightly yellowish tone, and does not appear to contain any aggregate (fig. 7).

Figure 7. The lower white plaster layer, and overlying thin white ground. Brush strokes can be seen in both layers, indicating that they were applied as quite liquid preparations

Because of the absence of aggregate in the plaster layers, their bright white color, and thin and liquid application, it is assumed that the plasters are gypsum-based. Additionally, where the lower plaster layer has undergone mechanical damage, it has deformed in a way which suggests that it is a soft and somewhat compressible material, which is not a property typical of lime plasters (fig. 8). Plasters at comparable sites throughout Cappadocia have been identified as lime or gypsum based, sometimes in combination (in separate layers or mixed in a single layer) (Pelosi et al. 2013, Schwartzbaum 1986), so the presence of a gypsum plaster at Üzümlü would not be unusual. The specific composition and application of the plaster (little to no aggregate; applied in thin, liquid layers by brush) may be less common, since it seems that many plasters were prepared with the addition of plant fibers (Pelosi et al. 2013). however there is a huge variety in the materials and quality of painting technology throughout the region, including some examples which are painted directly onto the rock, or others where the rock was prepared with a simple coating of whitewash, then painted (Schwartzbaum 1986).

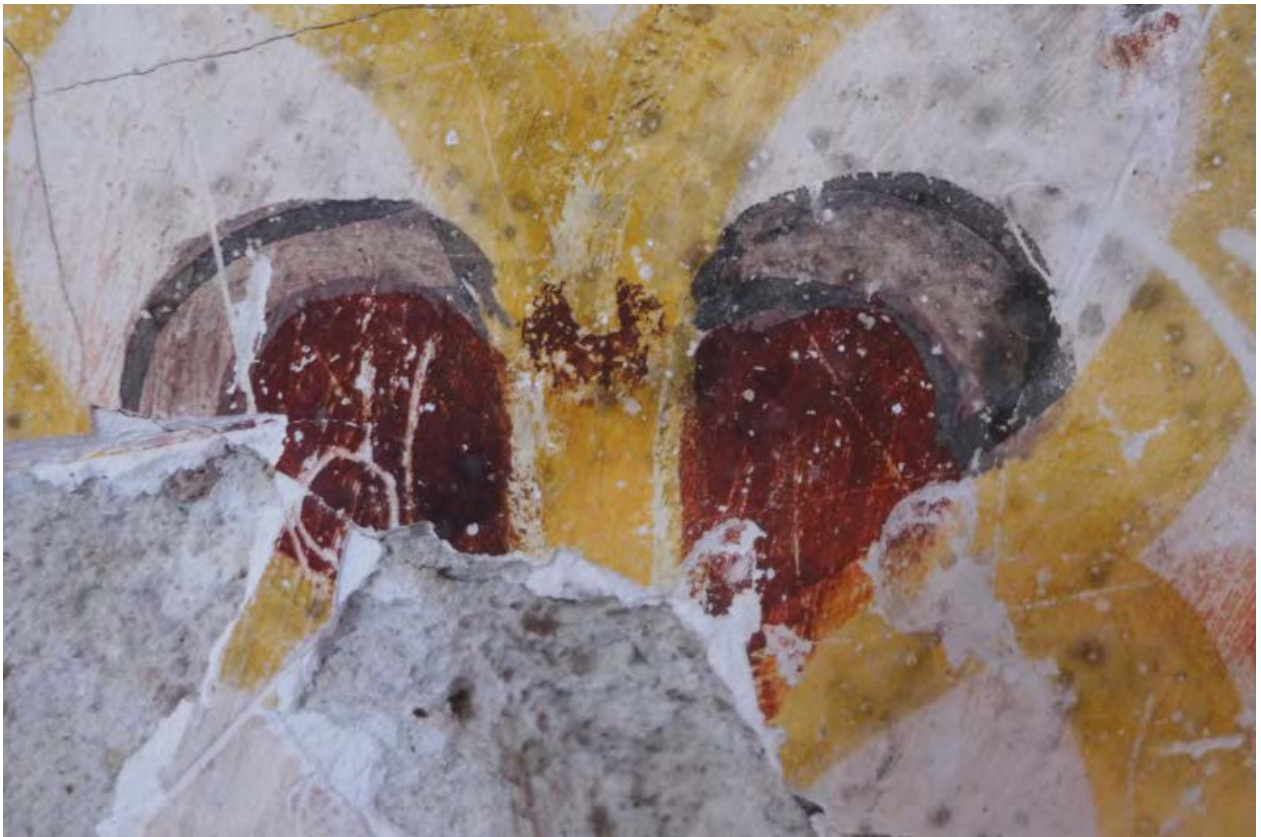
The paints often appear to have been applied in quite liquid, medium-rich preparations, resulting in some areas in thin, glaze-like effects (though this appearance may in part be due to deterioration, as discussed further below) (fig. 11). The smearing of layers in some areas, either due to mechanical action, dry or in the presence of water, also indicates that the paint layers were originally applied a secco, and further supports the hypothesis that the plaster layers are gypsum-based (fig. 12). Though Cappadocian paintings have often been reported as true frescoes (ex. Schwartzbaum 1986), there is also ample evidence that organic (often proteinaceous) binders were commonly used (Pelosi et al. 2013, Andaloro 2008).

Figure 11. The lighter purplish paint appears to have been applied as a medium rich, transparent wash layer

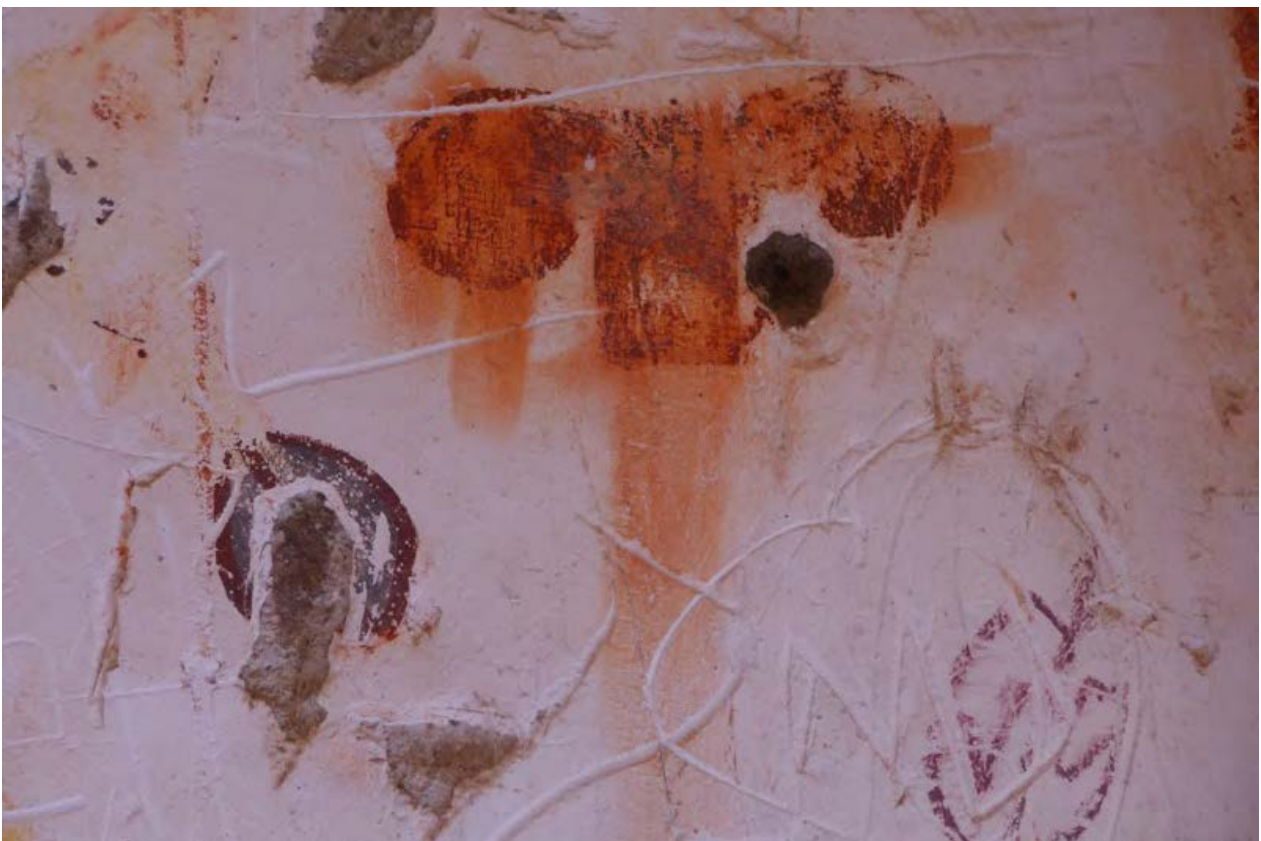
Figure 12. Smearing of the paint layers suggests that the pigments are bound with an organic medium

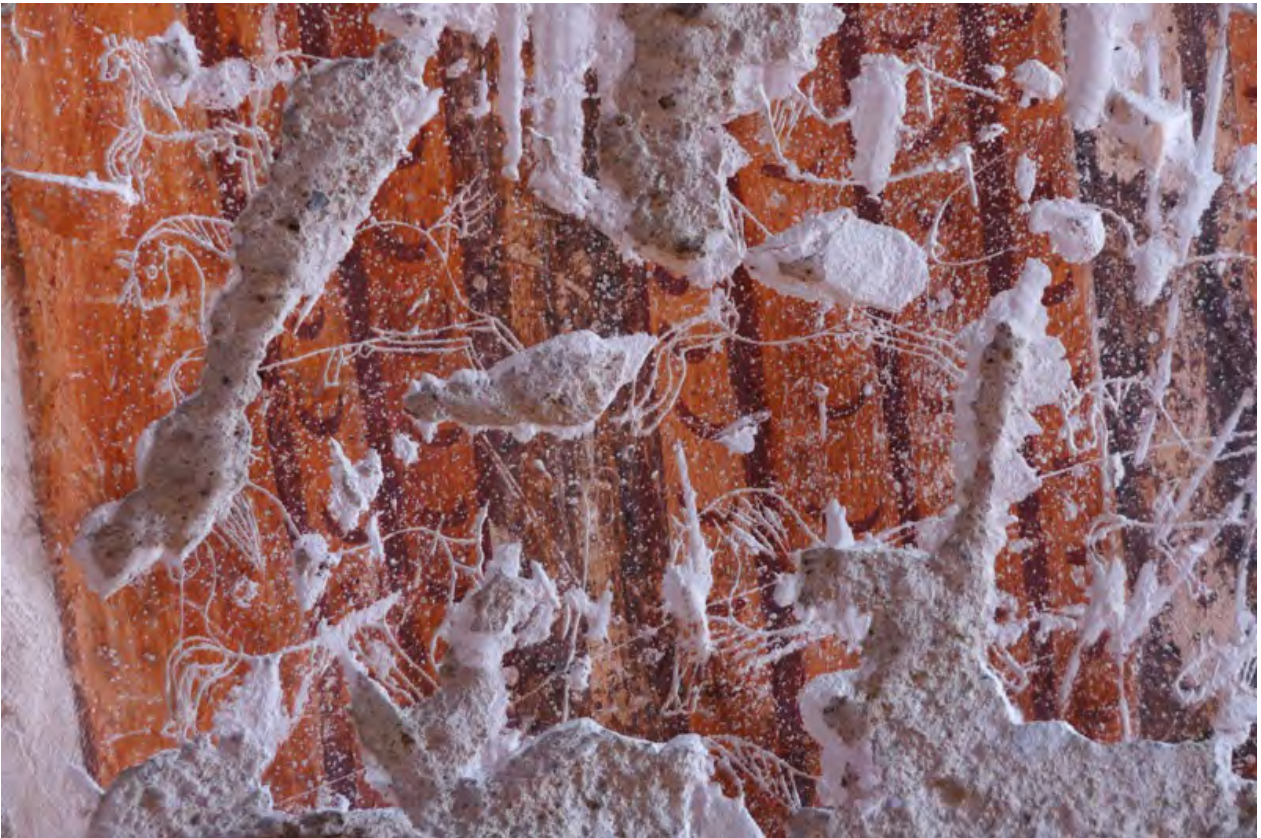
Human activity in the church over centuries has resulted in the most extensive deterioration phenomena, starting with the modifications to the structure which resulted in the destruction of portions of the scheme. Additionally, the paintings have been extensively graffitied over time, usually by incising words or figures into the plaster layers. The graffiti is generally restricted to areas which could be reached by a person standing at ground level, and so generally do not occur above a height of 1.5-2 m. This vandalism has continued up until relatively recently, and probably still continues, as evidenced by the presence of a phone number cut into one area of the painting (fig. 19). However, it is important to note that a large number of the graffiti are historically significant (ex. Greek inscriptions, images of horses and monks, exact dates as yet unknown) (fig. 20 & 21), and therefore their preservation must be taken into account when planning a conservation program for the paintings.

Figure 20. Historic graffiti depicting horses

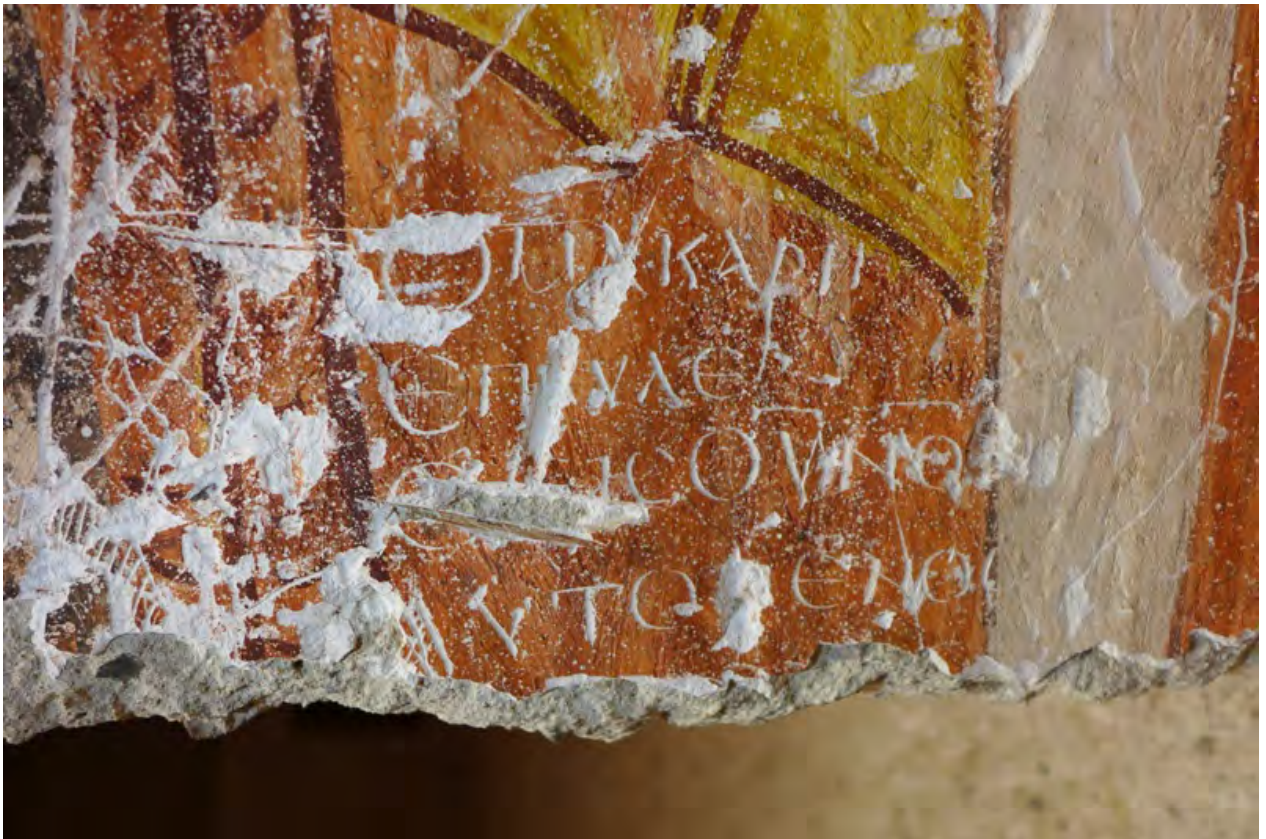
Figure 21. Historic Greek inscriptions

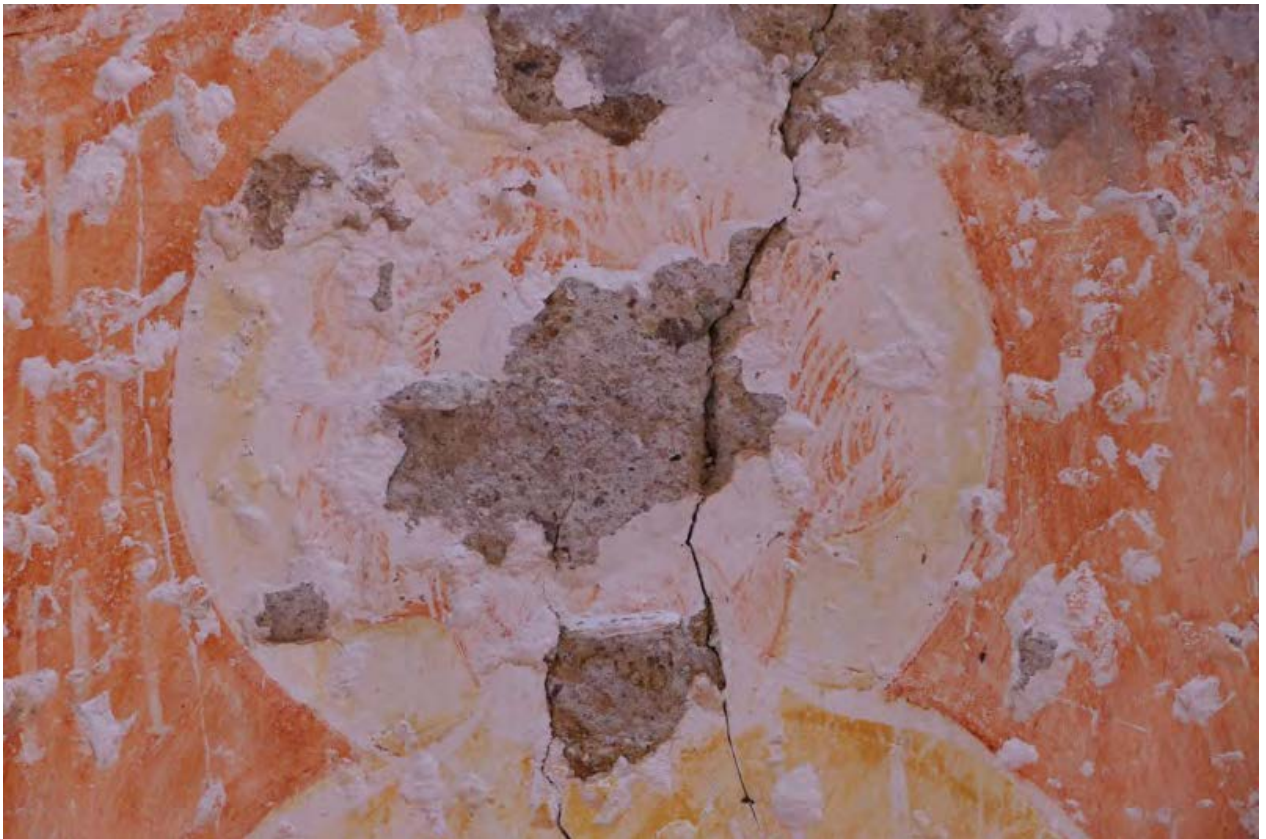
by iconoclasm or other differences in religious belief (fig. 22). The vandalism was inflicted by scratching, hitting, scraping and gouging (fig. 23 & 24). Generally, the damage cuts through the paint layer and into the plaster layers, but sometimes has caused the loss of all three layers, revealing the bare stone beneath. In some cases, impact has caused the compaction, deformation and cracking of the paint and plaster layers, but the stratigraphy remains intact (fig. 25). Like the graffiti, human-inflicted damage occurs mainly in the lower 1.5-2 m of the painting, but does extend to the height of the ceiling in some areas, in which cases it appears that sticks, rocks or other implements were used.

Figure 22. Example of vandalism directed at specific iconographic elements

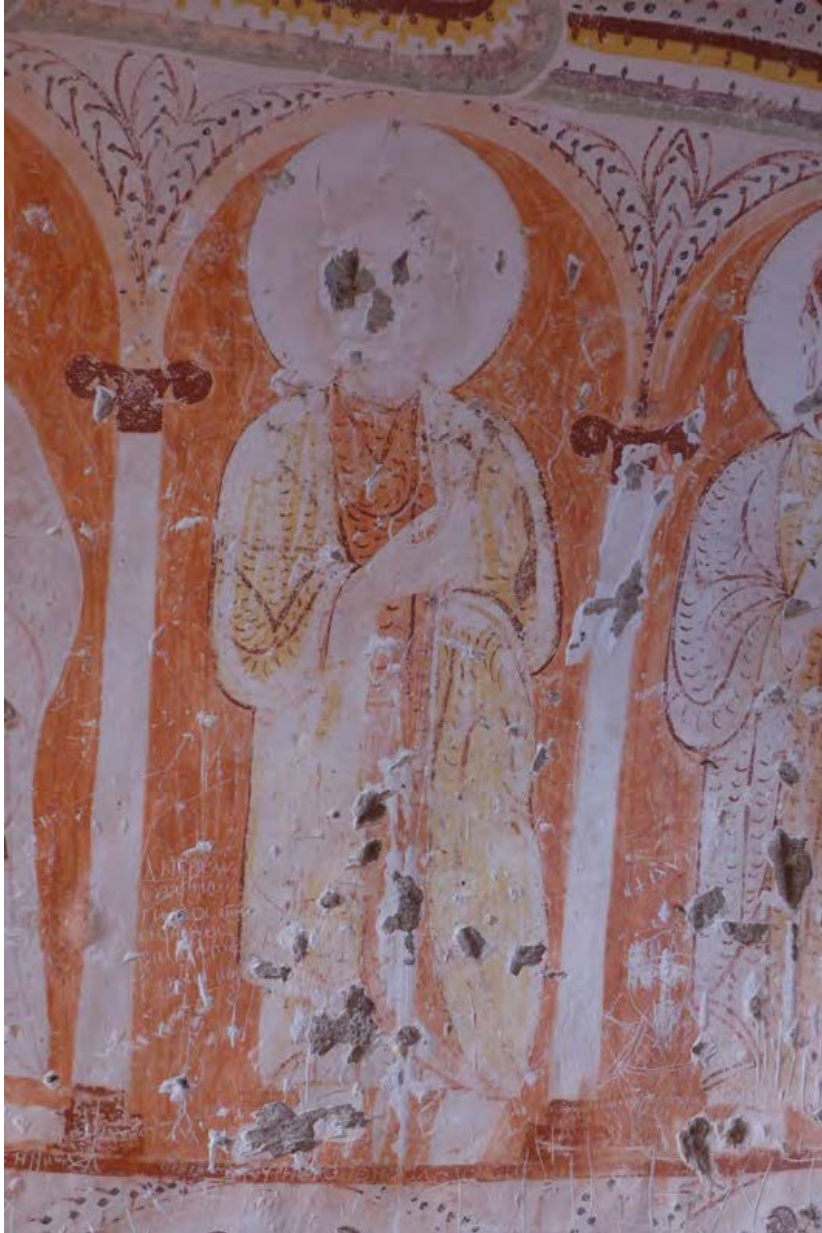
No powdering or flaking of the paint layers was observed, though they do appear to be friable, based on smearing observed in various locations. There are also areas of preferential loss, the mechanism of which is as yet unexplained, and may vary from area to area (fig. 27). It also does not affect paint layers in the same way across the painting, further confounding explanation. Loss could be due to chemical or physical changes within the paint layer, possibly a failure of the binder. The process is not yet clear, and will need to be investigated further. Preferential loss of paint layers has also been observed in other sites (Andaloro 2008), but further work would have to be done to determine if there are consistent patterns or causes between sites.

Boya tabakalarında toz haline gelme ya da pul pul dökülme gözlenmemesine rağmen bazı yerlerde karalamalara dayalı ufalanma gözlemlendi. Mekanizması henüz açıklanamayan ve bölgeden bölgeye farklılık gösteren öncelikli kayıp alanlar bulunmaktadır (Resim 27). Daha kafa karıştırıcı yorum ise, yine resim boyunca, aynı şekilde boya tabakalarını etkilemediğidir. Kayıp, boya tabakalarındaki kimyasal ya da fiziksel değişikliklerden, belki de bağlayıcı maddenin yetersizliğinden kaynaklanıyor olabilir. Süreç henüz net değil ve daha da incelenmesi gerekmektedir. Başka bir bölgede de boya tabakasının öncelikli kaybı gözlenmiştir (Andaloro 2008). Fakat, bölgeler arasında tutarlı örnekler ya da nedenler olup olmadığını belirlemek için daha fazla çalışma yapmak gerekmektedir.

Figure 27. Some paint layers in the face and robe of the figure have been completely lost, while others remain

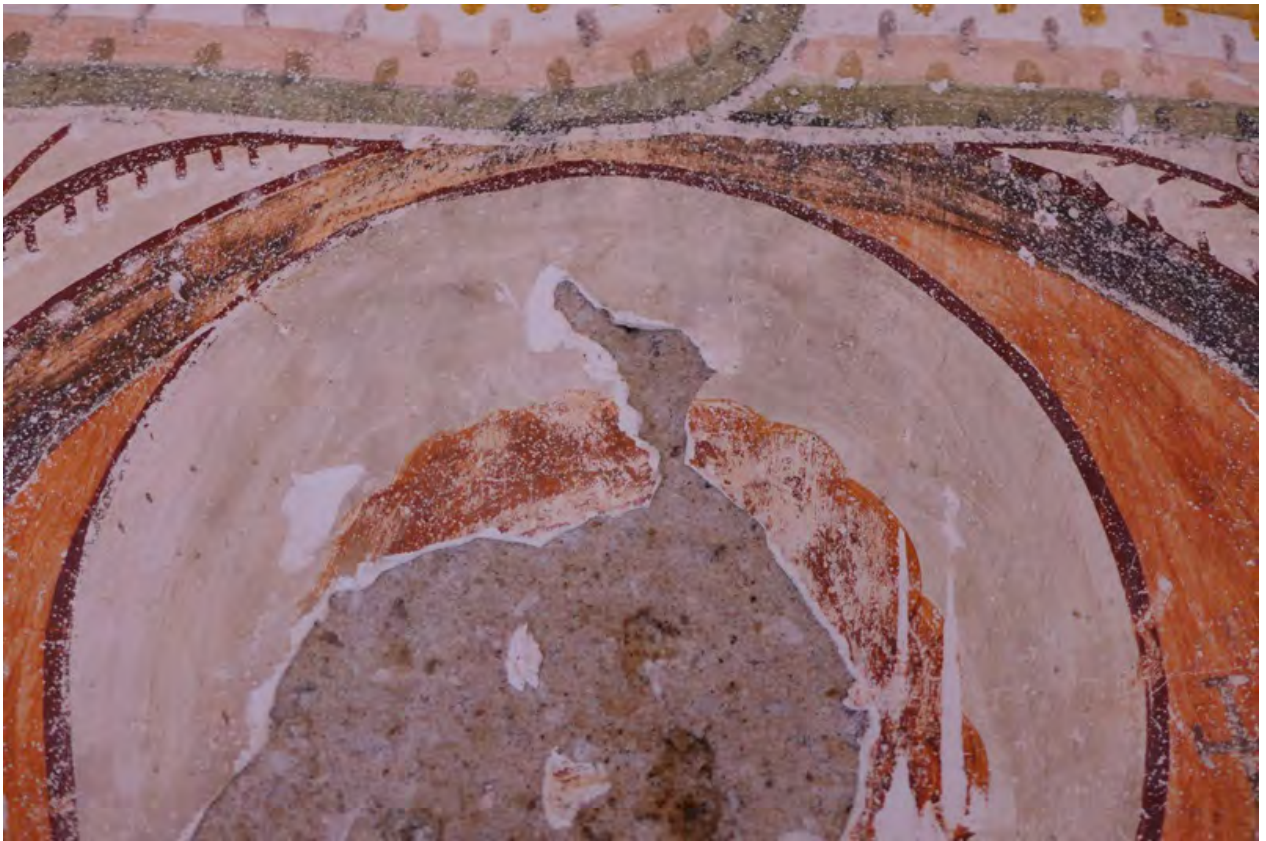
Figure 28. The paint layer in the halo appears to have altered to a grayish white hue

Pigment alteration was also observed, mainly as a shift from pink to grey, white to grey, and red to grey (fig. 28 & 29). Alteration of some type may also explain the current appearance of some of the other paint layers, but this cannot be understood without further examination and/or analysis.

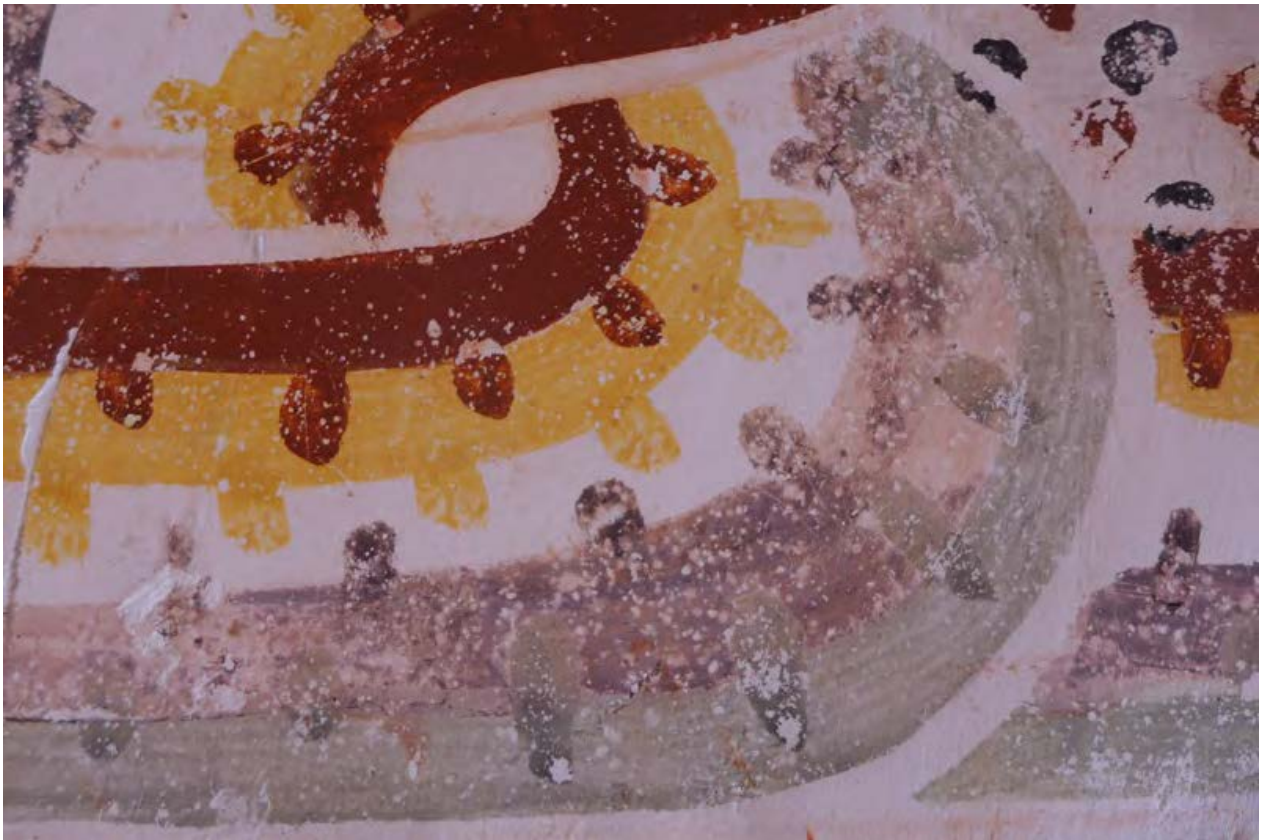
Figure 29. The pink paint layer appears to have altered to a purple black

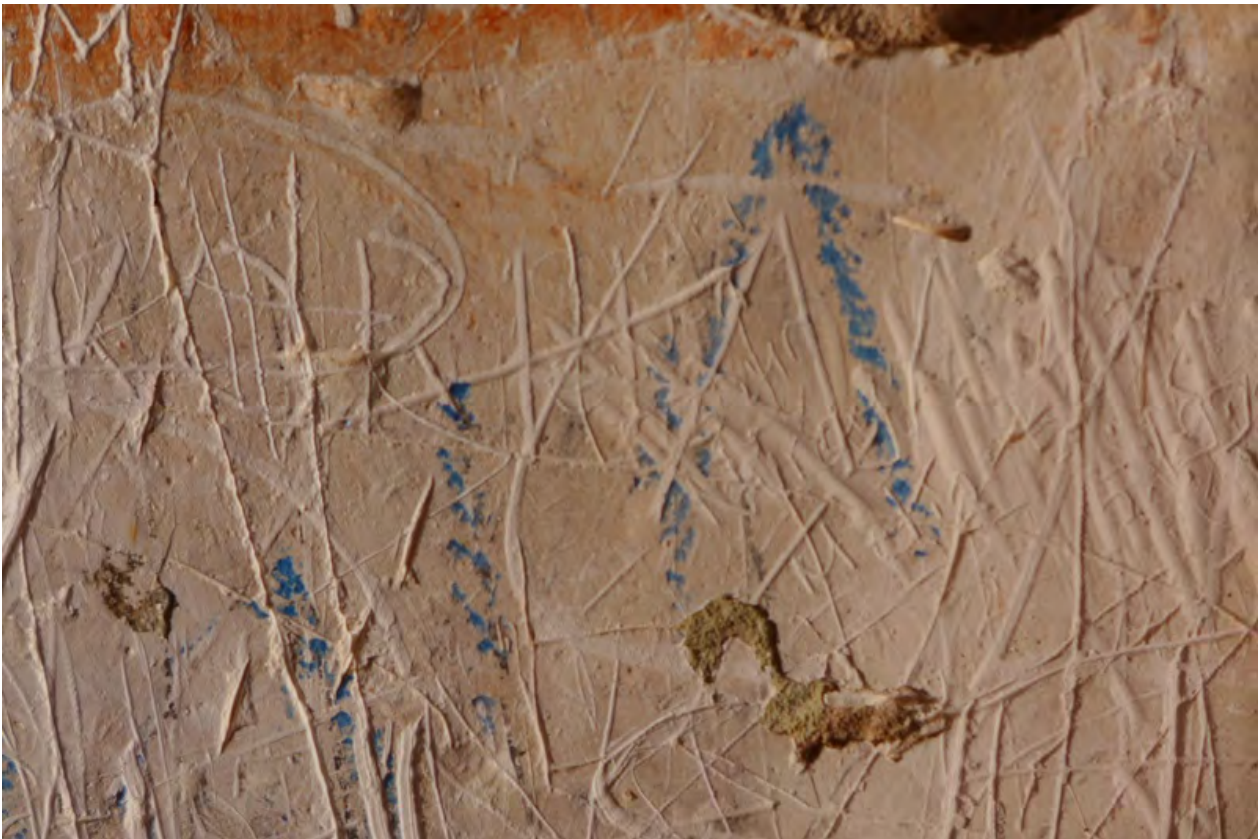
Figure 30. Superficial graffiti (in blue)

The paint layers have suffered the same mechanical damage as that described above for the plaster layers. The paint layers have additionally suffered from superficial graffiti (fig. 30), and smearing, a condition which has been exploited in a number of instances for the writing of graffiti (fig. 31).

Yukarıda alçı tabakalarındaki tarifte olduğu gibi, boya tabakaları da aynı mekanik hasara uğramıştır. Boya tabakaları buna ek olarak, çok sayıda grafiti örneği ile istismar edilmiş yüzeysel duvar yazısı (Şekil 30) ve karalama olayına maruz kalmıştır (Resim 1 31).

- The stabilization of some areas of detached or cracked plaster is recommended in order to prevent their loss over time. Partial treatment with fills, edge repairs and grouting should be applied only to the extent deemed necessary to ensure the paintings' stability, i.e. this should be designed as a partial treatment only, limiting the intervention to the minimum necessary to secure the paintings.
- Modern graffiti should be toned down in order to increase

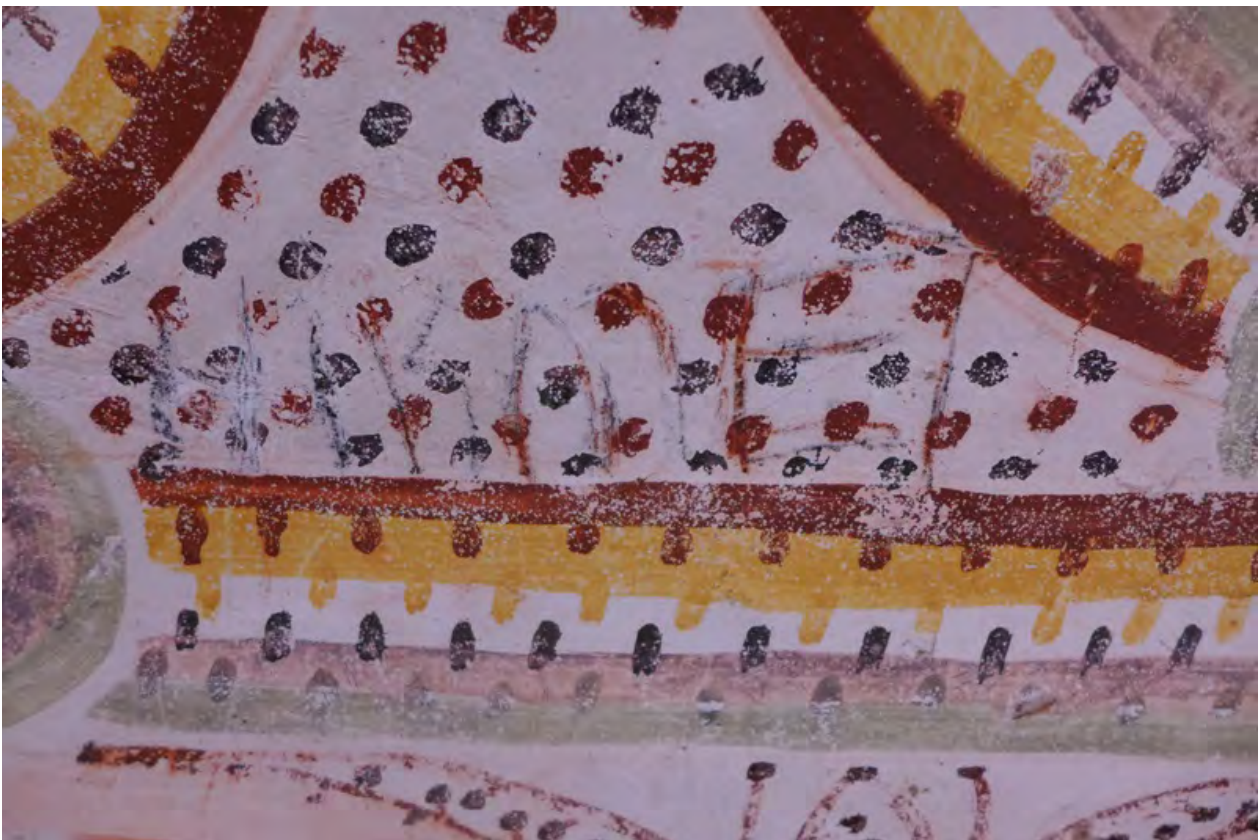
Figure 31. Graffiti created by smearing the original paint layers

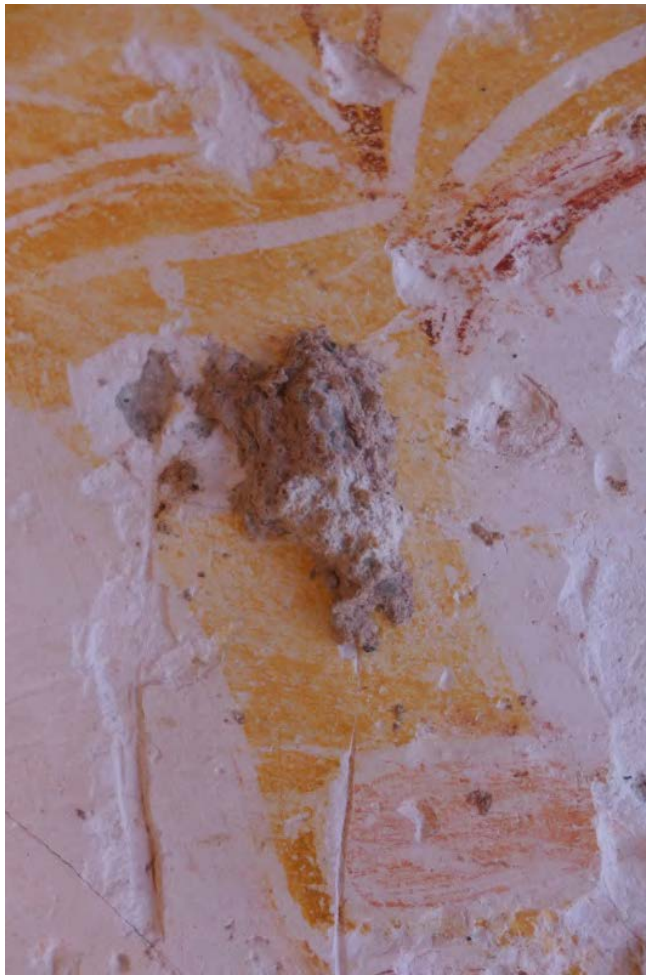
Figure 32. Earthen material used in bird nest construction deposited on the surface of the painting

The presence of animals has affected the paint layers through the deposition of material on the surface (ex. mud from nests, excreta), and the loss of paint when these materials have been removed (fig. 32 & 33). Contact with the animals has also resulted in the loss of paint layers in the form of scratching and other types of mechanical damage. Animals appear to have roosted mainly in Chamber 2.

Hayvanların varlığı, yüzeydeki materyal çökmesi (Or: Yuvaların çamuru, dışkı) ve bu materyallerin kaldırılması sonucu boyanın kaybı yoluyla boya tabakasını etkilemiştir (Şekil 32, 33). Hayvanlarla temas da, kazıma ve diğer mekanik hasar tipleri şeklinde boya tabakalarının kaybıyla sonuçlanır. Hayvanların genelde 2 No'lu odada tünedikleri görüldü.

- Continuing mechanical damage should be controlled through the installation of a well-fitted door with a narrower grid. This would prevent the entrance of humans and animals, greatly reducing the incidence of damage, though the visitation policy still leaves the paintings in danger of some amount of ongoing vandalism;
- There is unfortunately little which can be done to limit the structural failure of the church, since it is caused by the movement of the underlying fault line. However, cracking should certainly be monitored, and external cracks filled and maintained as necessary to prevent water infiltration to the church interior;
- Controlling or reducing ongoing external erosion is of course also fundamental to the long term preservation of the paintings, but is the subject of a separate report.

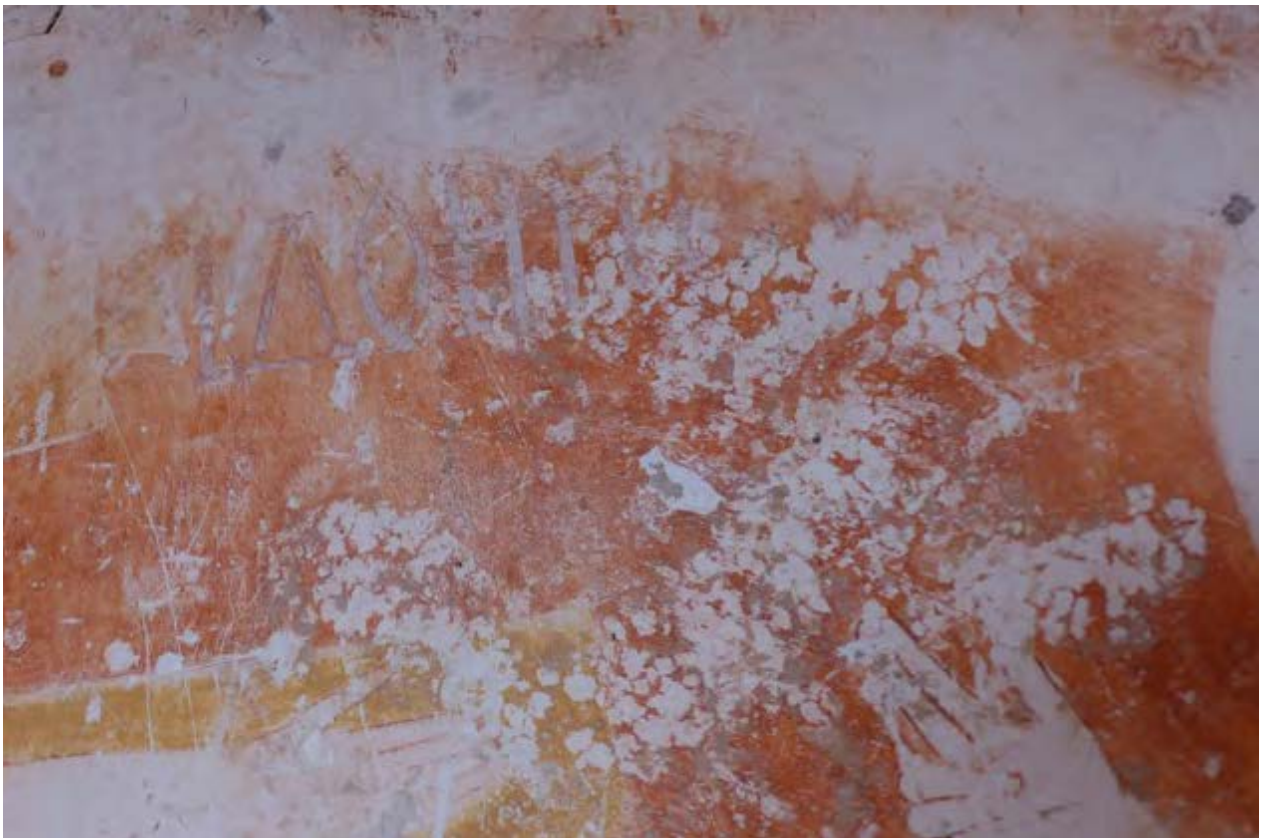
Figure 33. Remains of earthen nest material, and loss of the paint layer where it has been removed

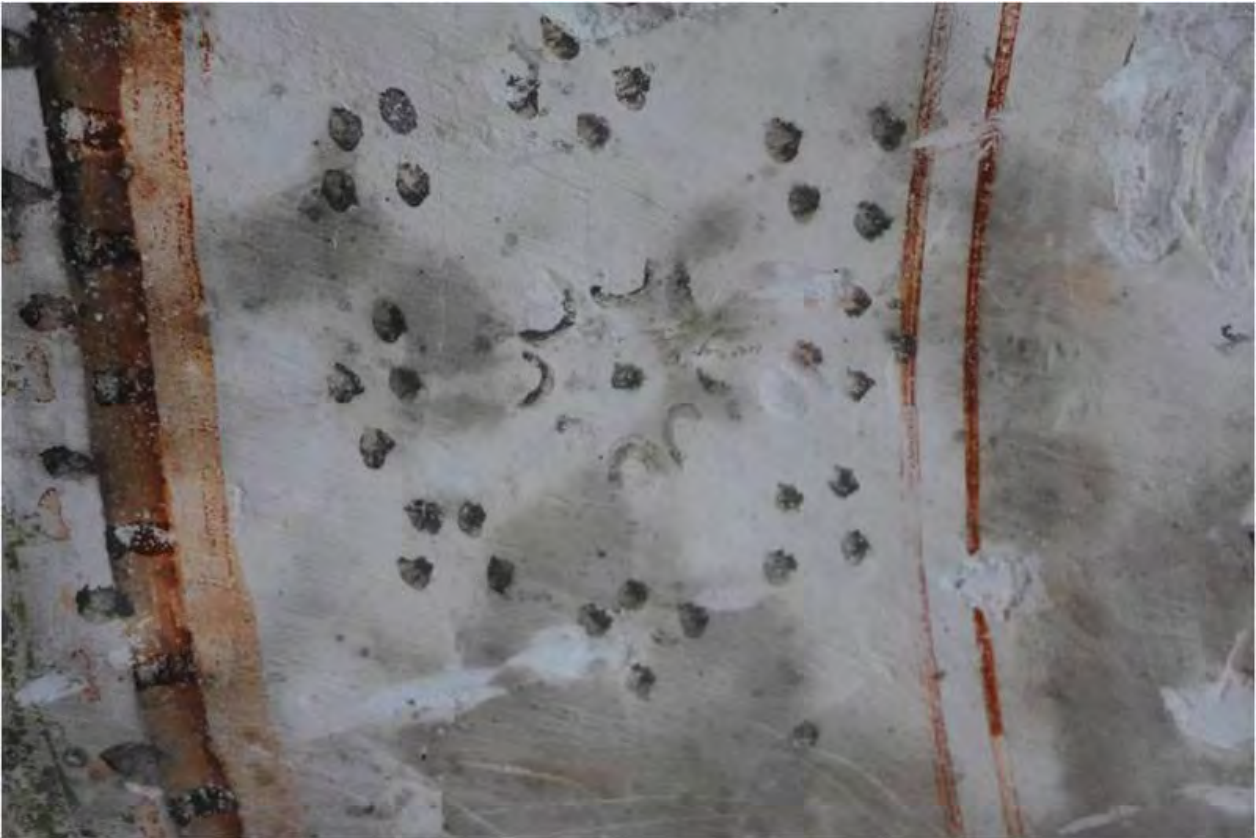
Figure 34. Grey veil which seems to be of biological origin

A number of phenomena were also observed which currently have are not fully understood. The first is a grey veil, often associated with black spotting (fig. 34), both of which seem to be of biological origin. These phenomena occur in particular areas of the painting, predominantly in Chambers 2 and 3, and at first viewing may appear to be the result of smoke deposition, though closer examination eliminates this hypothesis. A possibly related phenomenon is that of microlosses in the paint layer, generally circular and of approximately 0.5-2 mm Ø, which reveal the underlying ground layer (fig. 35). This phenomenon has been loosely associated with the grey veil and spots, mainly because they often manifest in similar locations, but this relationship has yet to be proven.

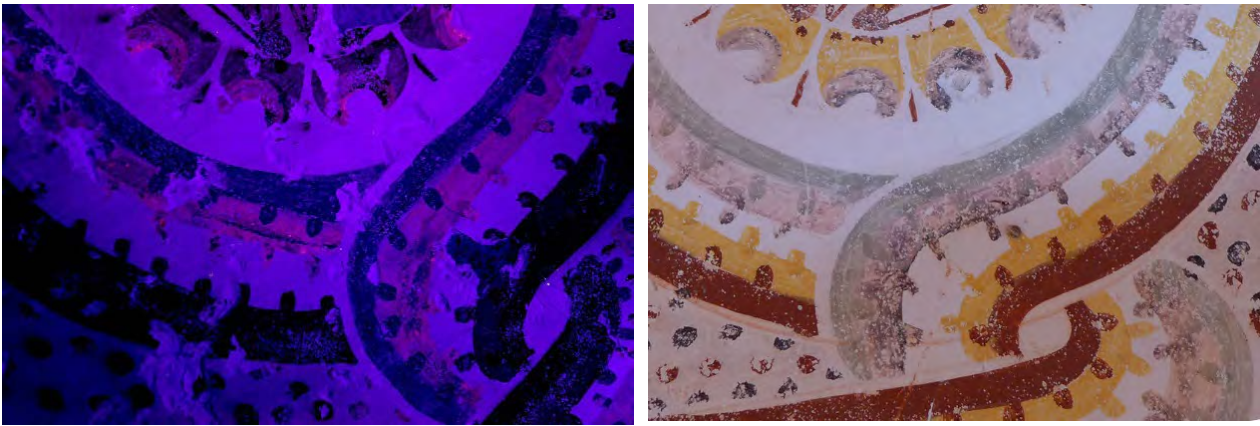
Photographs: 365nm-UV exited fluorescence visible photograph (left), and visible photograph (right) showing strong pinkish fluorescence of pale pink painted area with darkened alteration phenomena.

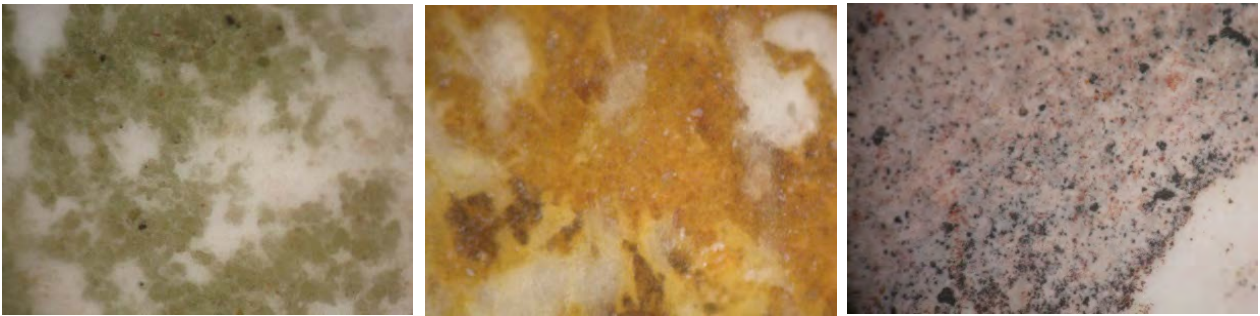
Microphotographs: (from left) 3rd chamber, main niche, greenish shade (3234), 3rd chamber, flower (3224), 2nd chamber, flower petal, altered (blackened) pink area (3208) [1.5mm in the long side]

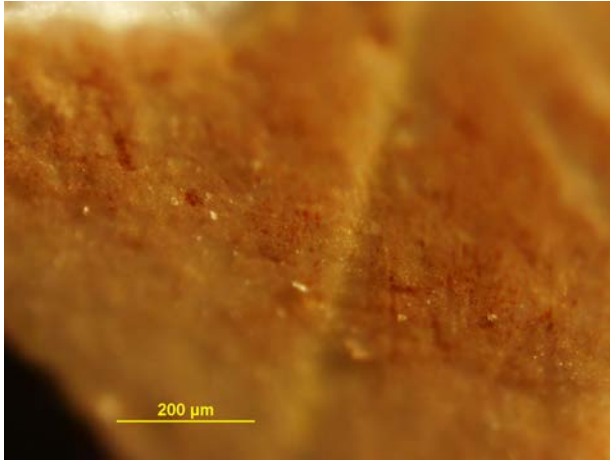
Figure 1. Light microscopic image of unembedded UZM\_003

**UZM\_003**, Oda 1'deki kırmızımsı yüzeyden alındı. Daha önceleri bu alanda üzüm figürleri olduğunu düşünmekteyiz (UZM007'nin alındığı alanda olduğu gibi). Üzümleri betimleyen resim muhtemelen su ile ilgili nedenlerden ötürü büyük ölçüde kaybolmuş. Reçineye batırılmamış örneğin yüzeyinde üzümlerin özgün rengine işaret edebilecek birkaç kırmızı parçacık gözlemlendi (Şekil 1). Kesitte, zemin tabakasının üst kısmında sadece birkaç demir içeren parçacık gözlemlendi (Şekiller 2, 3). Şu an için üzüm figürlerinin kaybolma nedeni bilinmiyor. Bu konu organik incelemenin sonuçlarına göre

A few red particles are dispersed on pink surface.

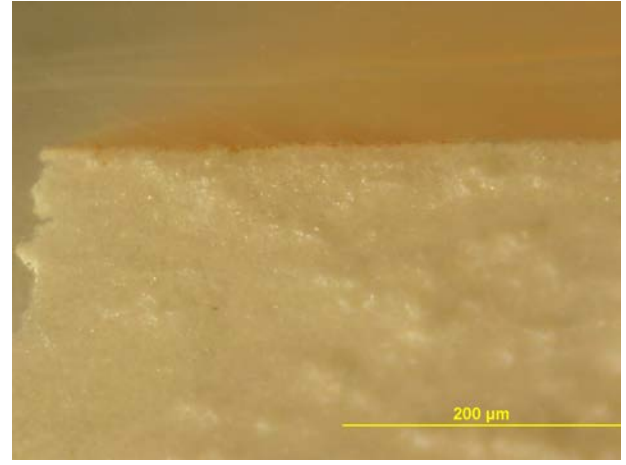
Figure 2. Light microscopic image of the cross-section UZM\_003

A very thin layer of red paint; small number of red particles are found at the surface of the white ground.
