# **Scientific Studies on Conservation for Üzümlü Church and its wall paintings in Cappadocia, Turkey**

**Vol. 1 : Annual report on the activities in 2014**

**University of Tsukuba  
2014**

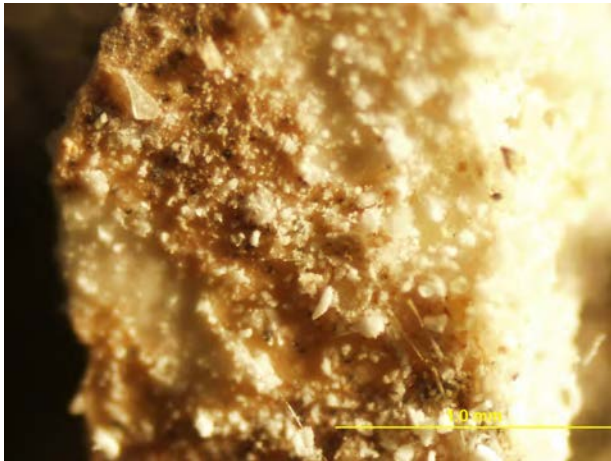
Figure 4. Light microscopic image of unembedded UZM\_004

Rough surface with red, black and white particles

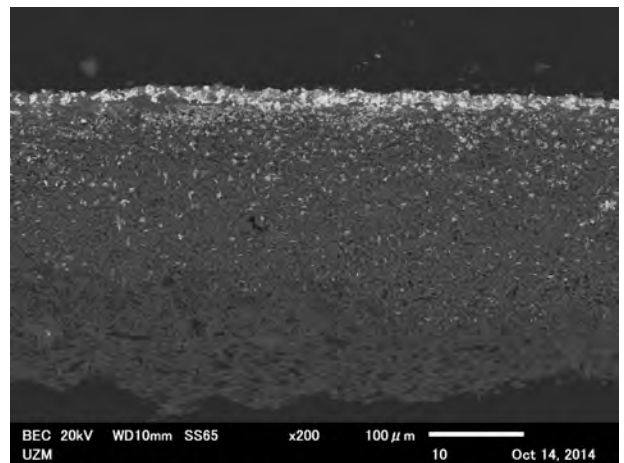
The darker area in the top layer contained calcium (Ca) and sulphur (S), which means that the ground and paint materials were somehow mixed. Brighter spots in the ground layer also contained lead (Pb) and chlorine (Cl) (Figure 8). Since there was no red or black particles in the ground layer, it suggested that decomposed red lead has somewhat impregnated into the ground layer. This could be related to a source of chlorine (Cl). A source of chlorine could be water soluble salts such as sodium chloride (NaCl).

Figure 8. SEM-BSE image of cross-section of UZM\_004  
Bright spots containing Pb and Cl are spread in the white ground layer.

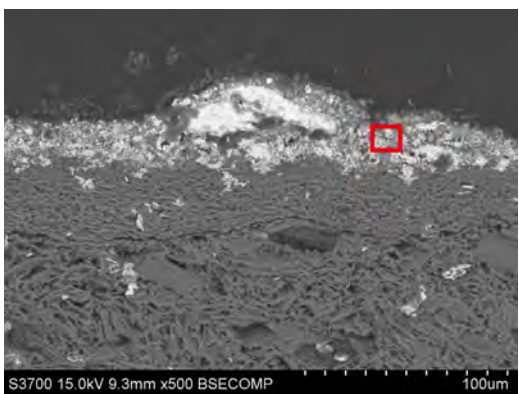
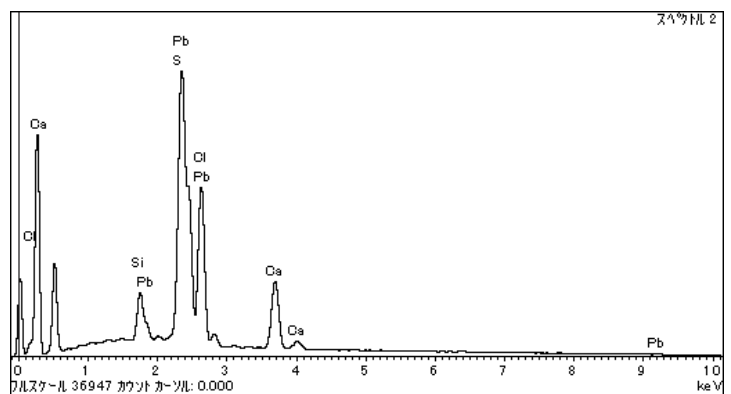
Figure 7. EDS area analysis result of the paint layer of UZM\_004

lead. Considering the brightness in contrast in the SEM-BSE images, the number of red and black particles in the top layer were very small, and it suggested the white particles could be degradation/alteration product of red lead (Figure 7).

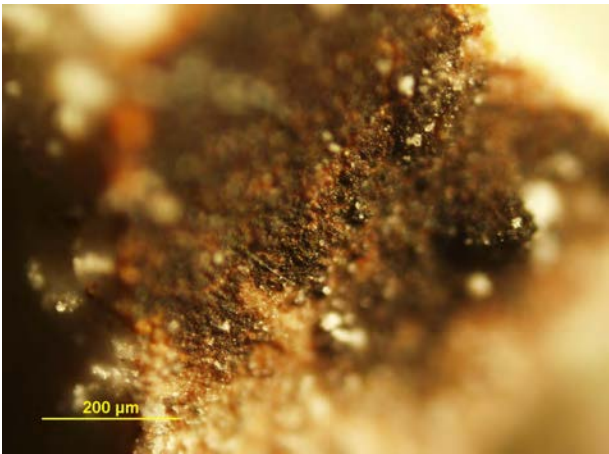
Figure 9. Light microscopic image of unembedded UZM\_005

**UZM\_005** is a darkened red paint sample from the ceiling of Chamber 2. Observation with the light microscope indeed reveals the presence of red and black particles. The surface was darkened while the red colour was preserved underneath the darkened particles (Figure 9). In the cross-section, however, this observation was not obvious probably because of that only surface particles were altered.

The red particles are visible under the surface dark particles.

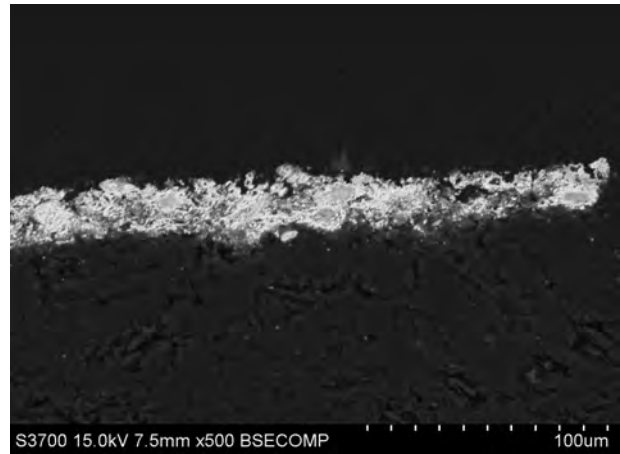
Figure 10. SEM-BSE image of cross-section of UZM\_005

Moreover, in the SEM-BSE image the top layer was highly X-ray reflective that did not correspond to the locations of the red and black particles (Figure 10). As it was seen in UZM\_004, both black and white particles in the top layer were assumed to be alteration products of red lead. Based on the EDS analysis, a difference from UZM\_004 was the top layer which does not contain chlorine (Cl) and also no migration of lead (Pb), which was observed in UZM\_005. Reasons for the differences between two samples should be examined further in the future.

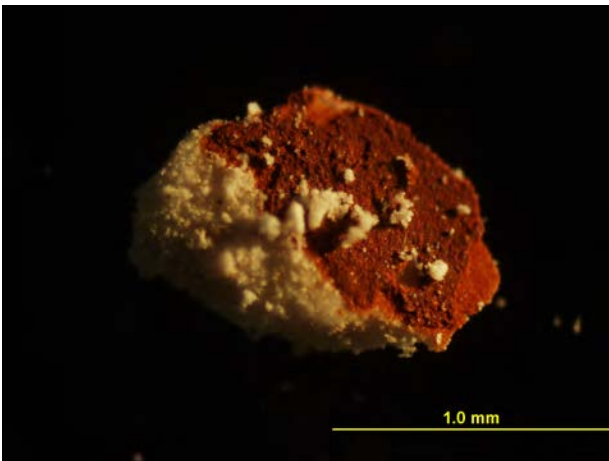
Figure 11. Light microscopic image of unembedded UZM\_007

**UZM\_007** is a red paint sample taken from grape images depicted area on the ceiling of Chamber 2. The surface appeared darker than underlying material in the light microscopic image of the unembedded sample (Figure 11). However this difference was not obvious in the cross-section, and the light microscope and SEM-BSE examinations suggested that the dark surface was due to accretion of dirt

**UZM\_007**, Oda 2'nin tavanındaki üzüm figürlerinin betimlendiği bölümden alınan bir kırmızı boya örneğidir. Reçineye batırılmamış örneğin ışık mikroskobu görüntüsünde yüzey, alt kısmından daha koyu görüldü (Şekil 11). Ancak bu farklılık, kesitte ne ışık mikroskobu ne de SEM-BSE kullanıldığında belirgindi ve bu durum koyu yüzeyin kir birikmesinden kaynaklandığını düşündürdü (Şekil 12).

Surface is darker than the red particles underneath.

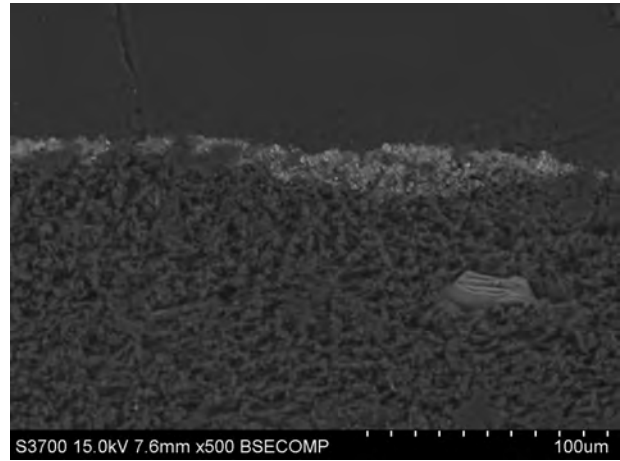
Figure 12. SEM-BSE image of cross-section of UZM\_007

(Figure 12). EDS analysis detected iron (Fe) with silicon (Si) in the red paint layer indicating the use of red ochre (Figure 13).

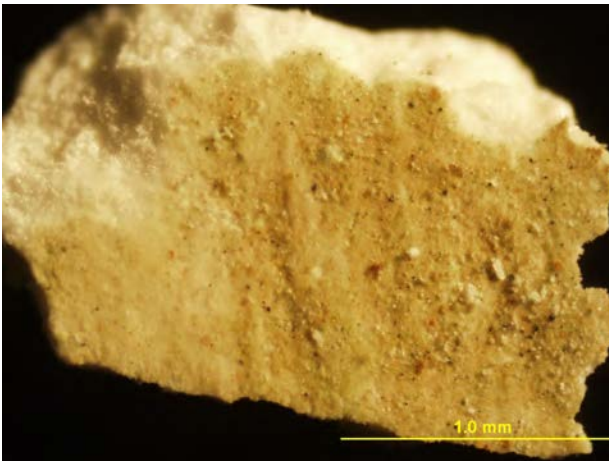
Figure 14. Light microscopic image of unembedded UZM\_008

**UZM\_008** was taken from a green area on the ceiling of Chamber 2. In the light microscopic image the green colour was very pale and the top layer contains various types of particles shown under UV-light (Figures 14, 15). The top layer is distinguishable from the ground in the SEM-BSE images as the crystal structure was slightly different. EDS detected silicon (Si), aluminum (Al), magnesium (Mg), potassium (K), and iron (Fe) which are typical elemental compositions of green earth (Figure 16). In order to identify a type of green earth (glauconite or celadonite) further analysis with XRD and/or FTIR is required.

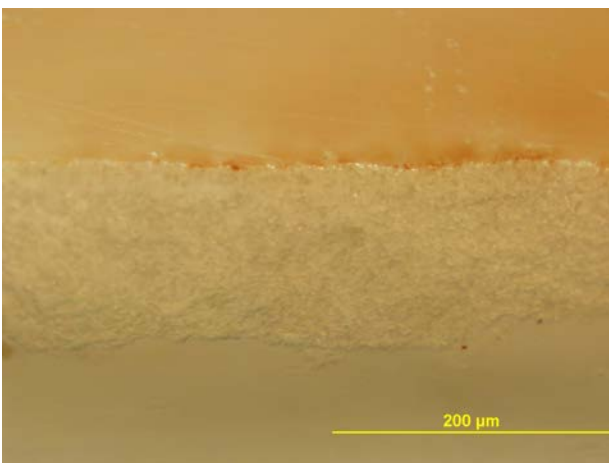
Figure 17. Light microscopic image of the cross-section UZM\_010 with the square.

**UZM\_010** is a pale pink paint taken from the west wall of Chamber 2. The layer was extremely thin and only small numbers of red particles were dispersed on the ground (Figure 17). The red particles contain iron (Fe) detected with EDS indicating the use of red ochre, probably refined in a specific way.

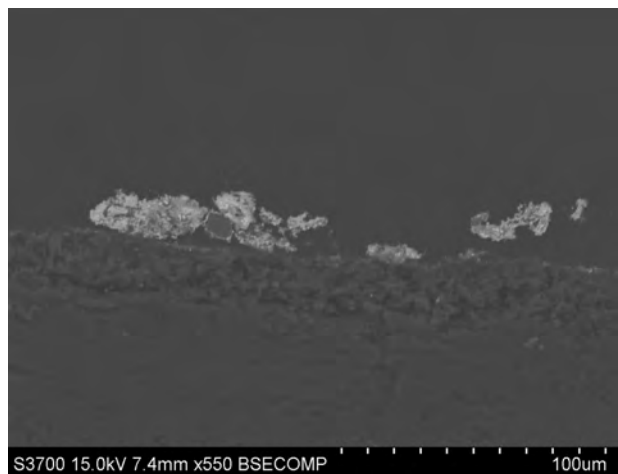
Figure 18. SEM-BSE image of cross-section UZM\_011

**UZM\_011** was taken from a darkened red area of the west wall of Chamber 2. The surface condition was close to the UZM\_005. As expected, EDS detected lead (Pb) in the red paint layer. Again there was no difference observable between intact red particles and altered black particles in the SEM-BSE images. In this sample, delamination of the paint layer was clearly shown in the SEM-BSE image (Figure 18).

**UZM\_011**, Oda 2'nin batı duvarındaki koyu kırmızı bir alandan alındı. Yüzey koşulları UZM\_005'inkine benziyordu. Beklendiği gibi, EDS kırmızı boya tabakasında kurşun (Pb) tespit etti. SEM-BSE görüntülerinde, bozulmamış kırmızı parçacıklarla değişime uğramış siyah parçacıklar arasında gözlenebilir bir farklılık bu kez de yoktu. Bu örnekte, boya tabakasındaki delaminasyon SEM-BSE görüntülerinde açık şekilde görülmekteydi (Şekil 18).

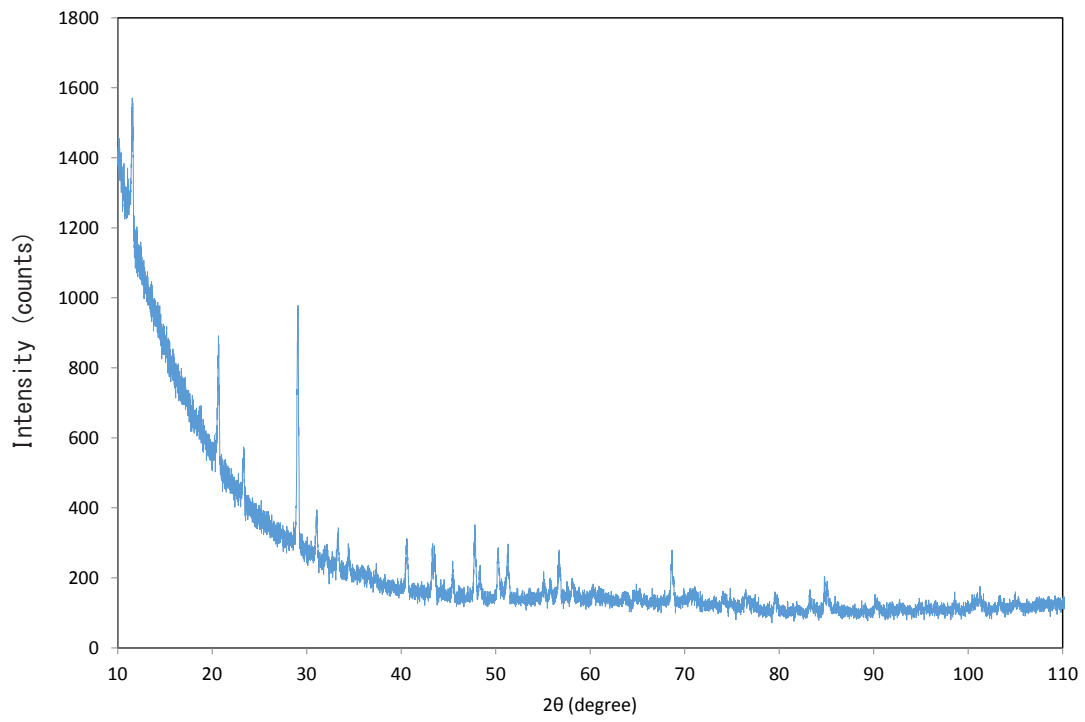
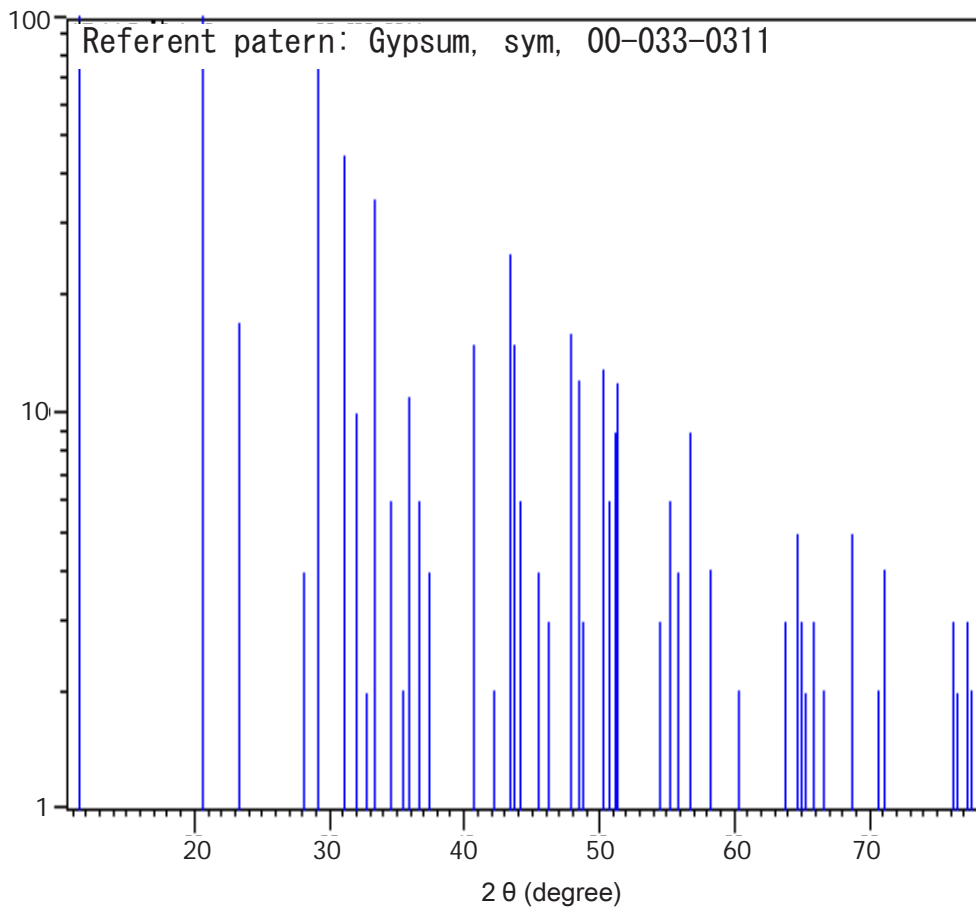
Figure 19. XRD diffractogramme of UZM\_002 white ground and a reference diffractogramme of gypsum [JCPDS: 00-033-0311]

The samples UZM\_002 and UZM\_013, which were taken for identification of the white ground, were analyzed by the XRD. Gypsum was identified in both samples. The XRD diffractogramme is shown in Figure 19 (JCPDS: 00-033-0311). In addition, crystal structure of the two samples (unembedded) showed characteristic shapes of gypsum crystals (Figure 20). Detections of calcium (Ca) and sulphur (S) with EDS in the all samples supported the XRD results (Figure 21) as calcium sulphate hydrate; gypsum ( $\text{CaSO}_4 \cdot 2\text{H}_2\text{O}$ ).

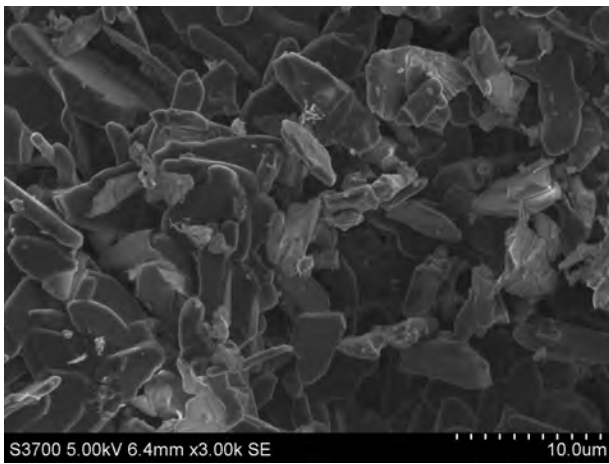
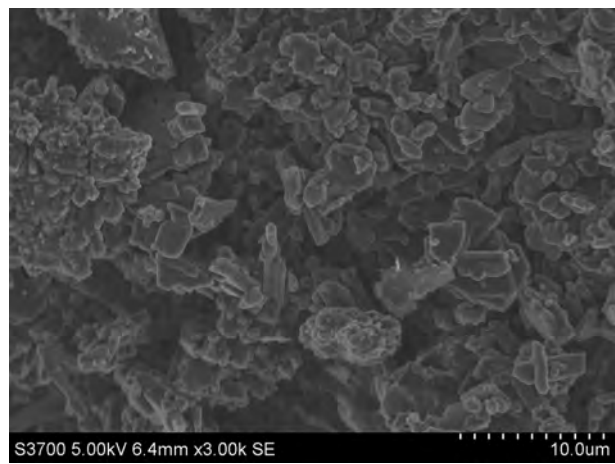
Figure 20. SE(secondary electron) images of UZM\_002 and UZM\_013 (both white ground samples) showing typical gypsum crystalline shapes (UZM\_013 might be a little degraded)

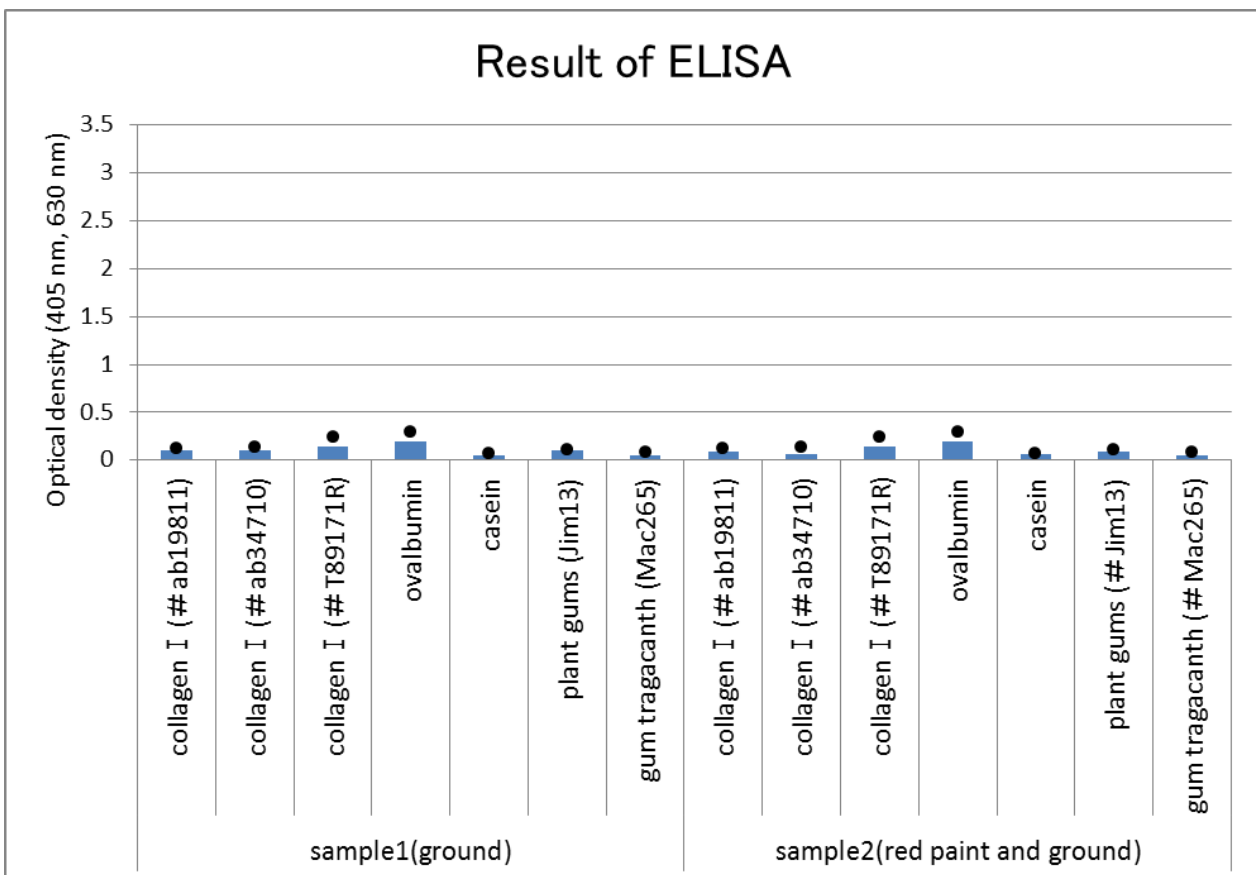
Figure 2. ELISA result for the identification of the binding medium of sample 1 (ground) and sample 2 (red paint and ground). 4 dilutions were prepared from each sample, one for each antibody and the average absorbance of 4 dilutions are shown (bar chart). No collagen I , ovalbumin, casein, plant gums and gum tragacanth were detected in the both sample. The dots indicate the cut-off values.

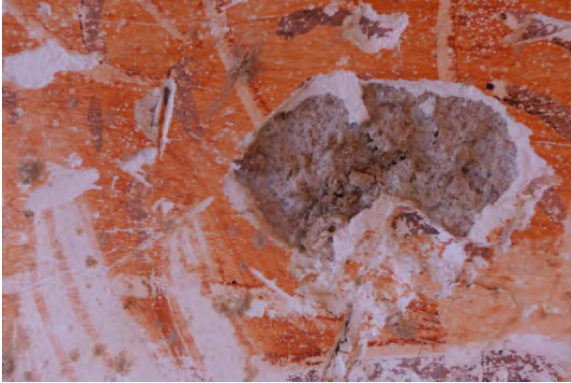
<p>BIYOLOJIC BOZULMA</p>	<p>BIOLOGIC ACTIVITY</p> <p>Evidence of animal inhabitation (insects, spiders). Often, they appear to have inhabited pre-existing fractures in the rock, possibly exacerbating deterioration</p>

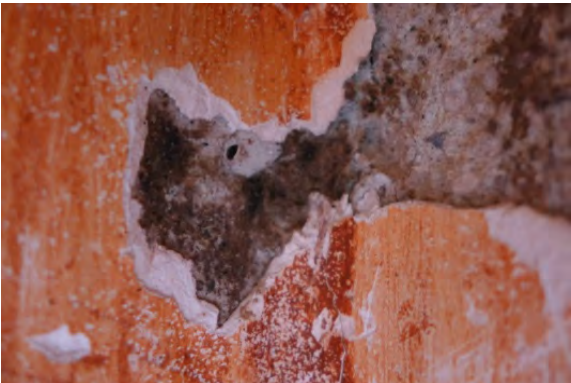
<p>SIYAPLAŞMA</p>	<p>DEPOSITION OF DARK MATERIAL</p> <p>Deposits of dark brown or blackish material on the surface of the rock. Its origin is unclear, but it may be caused by biologic activity (ex. insects, bats). It appears to have been deposited on the stone after a loss of plaster, but this is uncertain – similar deposits do not appear on the surface of the plaster or paint layers. Could it have formed under the plaster and contributed to detachment? If of insect or animal origin, what caused the depopulation?</p>

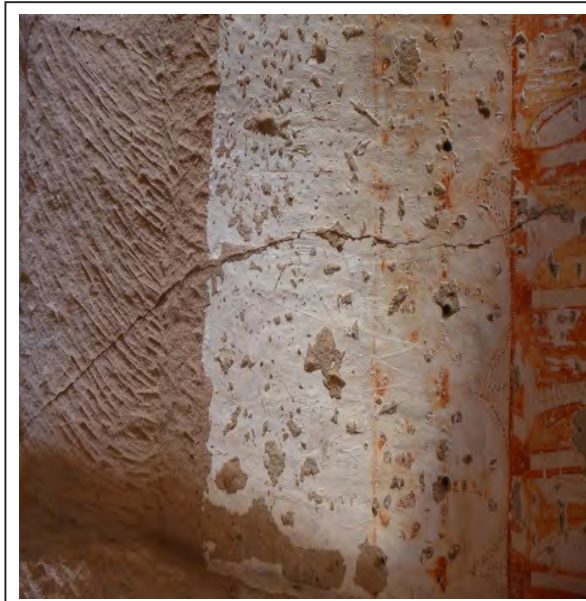
YAPISAL ÇATLAH

STRUCTURAL CRACKS

Large cracks which run through the body of the rock, caused by faulting

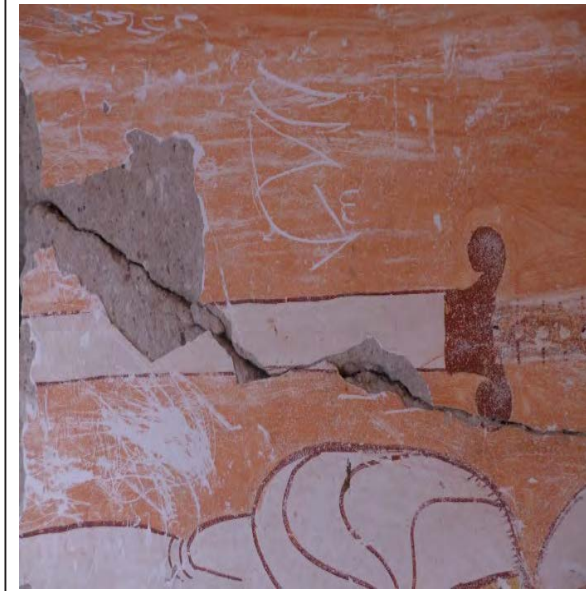
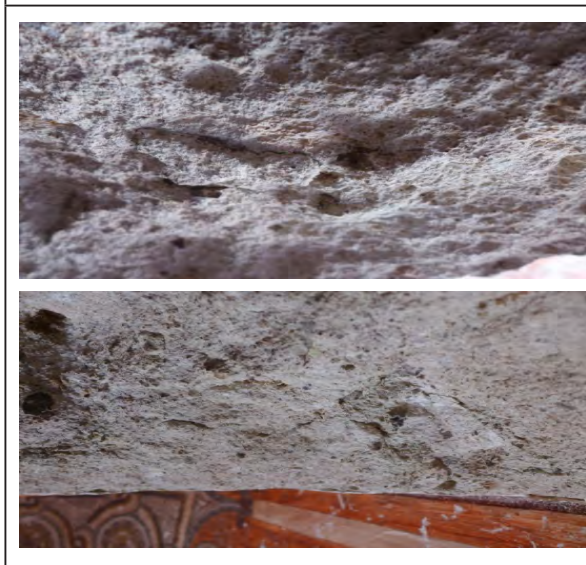
YÜZEYDE KÜÇÜK ÇATLAK

SPALLING

Detachment of the rock on a small scale, in parallel to the surface of the rock, probably more due to internal failure of the rock itself than macro-failure of the structure, though the two factors may be inter-related

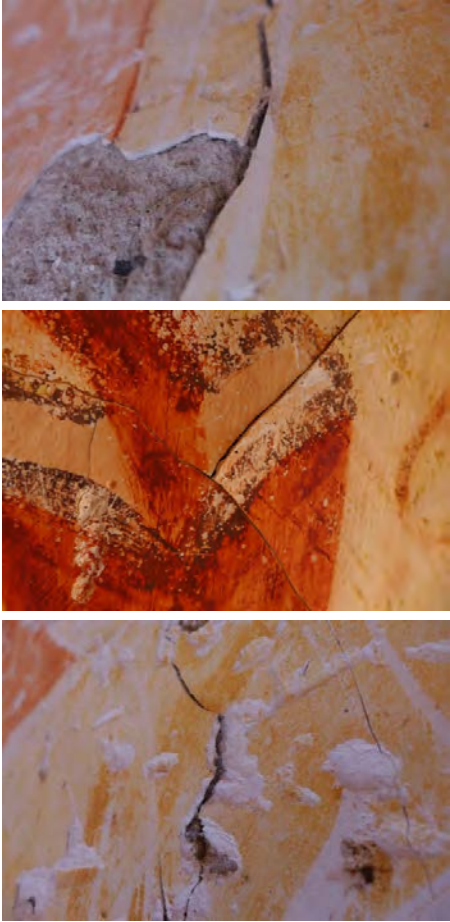
<p>SIVA TOBAKASINDA AYRILMA</p>	<p>DETACHMENT OF LOWER PLASTER LAYER</p> <p>Loss of adhesion between the lower plaster layer and rock substrate, as assessed by visual evidence alone. In general, the observed detachment appears to result from mechanical damage to the surrounding areas, or structural cracking, though it may be more extensive</p>

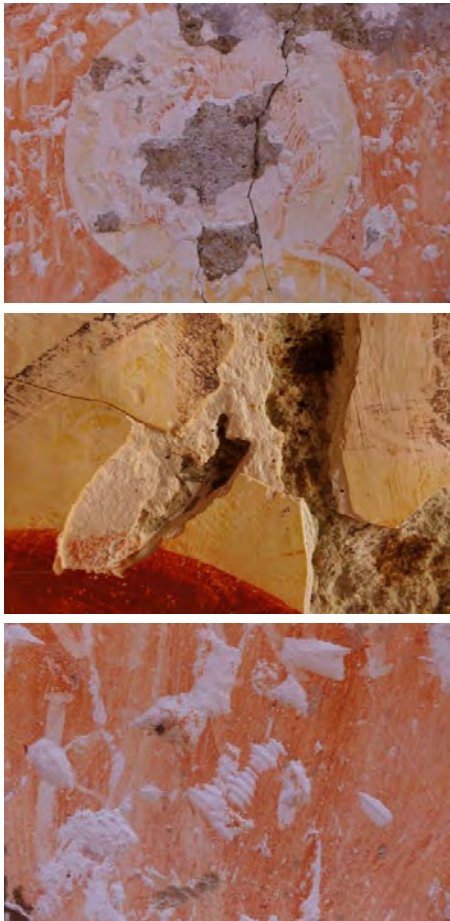
<p>MEKANİK HASARLAR (insan eliyle yapılan hasar)</p>	<p>MECHANICAL DAMAGE</p> <p>Rupture of the painting stratigraphy by human or animal action, causing a variety of damage types: loss of the entire stratigraphy, revealing the underlying rock substrate; loss of the paint layer, ground and part of the lower plaster layer, leaving the interior of the lower plaster layer exposed; loss of only the upper plaster ground, leaving the surface of the lower plaster layer intact; deformation of the painting stratigraphy, which otherwise remain intact. Often appears as scratching, gouging, or denting. Damage was often directed at specific iconographic elements (ex. faces, hands, books).</p>

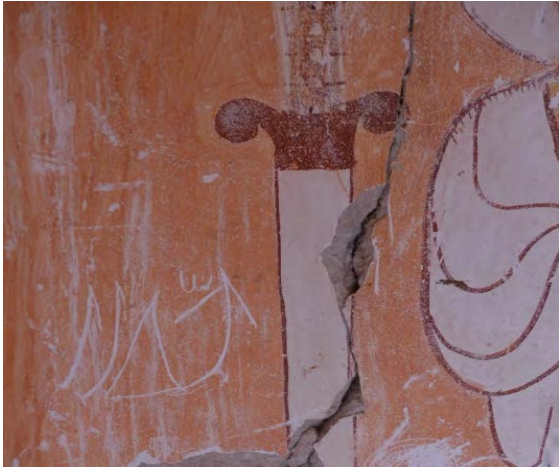
<p>BÜTÜN ÇATLAKLAR</p>	<p>CRACKING</p> <p>Cracking of the plaster layer most often resulting from cracking of the rock structure and mechanical damage, though there may be other causes</p>

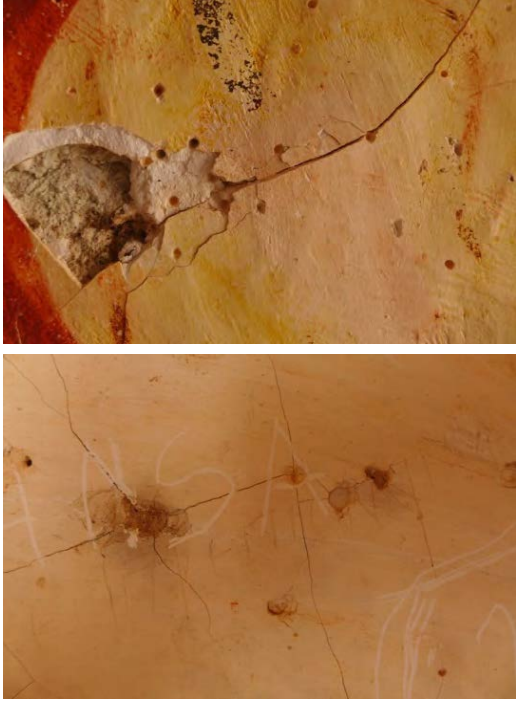
<p>DELIKLER (5mm ø)</p>	<p>HOLES</p> <p>Very circular, small holes of approximately 5 mm Ø, which enter into the plaster layer and generally do not reach the substrate. Cause is unknown as of yet.</p>

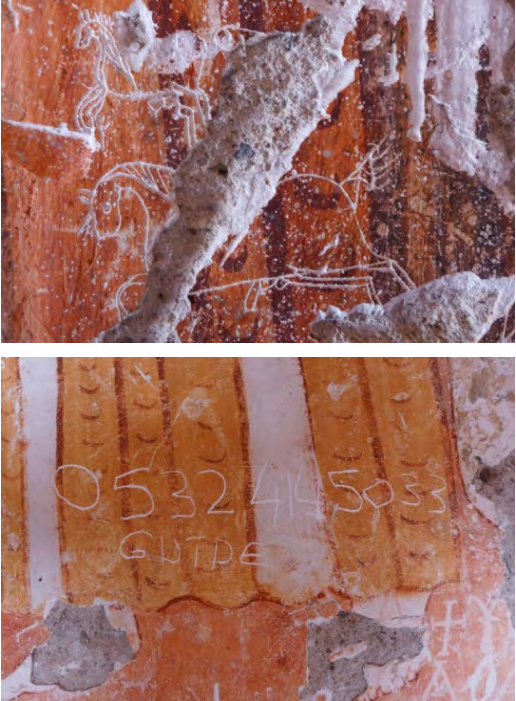
<p>GRAFİTİ</p>	<p>INCISED GRAFFITI</p> <p>Inscriptions and drawings incised into the surface of the painting, affecting the paint layer, ground and plaster layer. Some graffiti appears to be ancient (written in Greek; imagery of horses, monks etc), but a significant proportion is modern (based on writing, dates, phone numbers ...).</p>

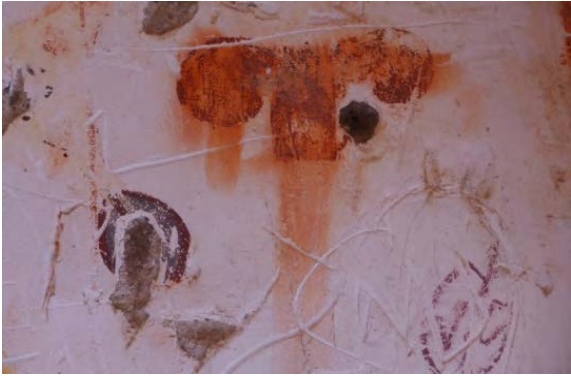
LEKELENMELER	<p>SMEARING</p> <p>Displacement of the paint layer by mechanical action beyond its original location, seen as a spreading of the paint across the surface of the plaster. Generally appears to have been caused by contact with the paint layer, perhaps in combination with the presence of water</p>

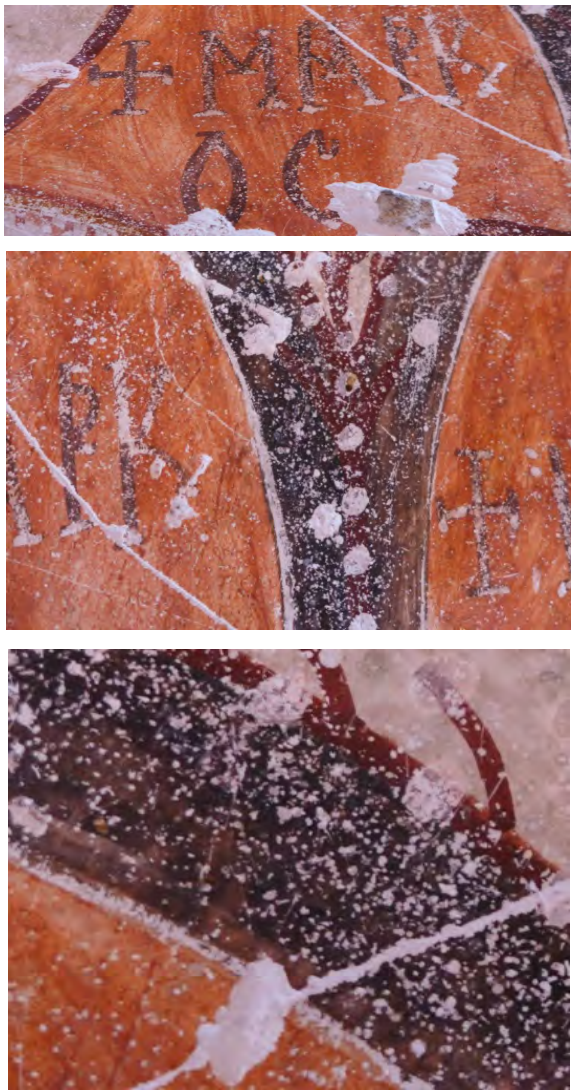
MIKRO KAYIPLAR	<p>MICRO LOSSES</p> <p>Extremely small, rounded losses of the paint layer generally on the order of 0.5-1 mm Ø. Not always confined to specific paint layers, but does appear to be somewhat location-specific</p>

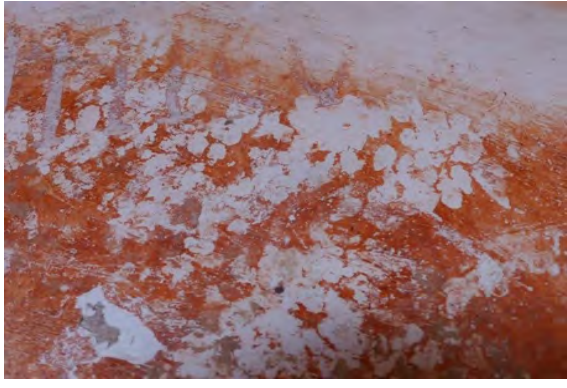
<p>BİYOLOJİK NEDENLERLE BOYA TABAKASINDA KAYIP</p>	<p>PAIN T LAYER LOSS DUE TO BIOLOGIC ACTIVITY</p> <p>Loss of the paint layer due to the former presence of birds' nests (primarily) which, when separated from the painting surface, removed part of the paint layer</p>

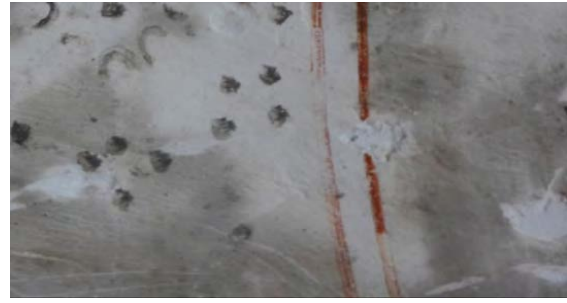
<p>KOYU GRI LEKELENMELER</p>	<p>DARK GREY VEIL</p> <p>Veil extending over the surface of the painting, dark grey in color, somewhat patchy, and of unclear origin. Does not appear to be soot.</p>

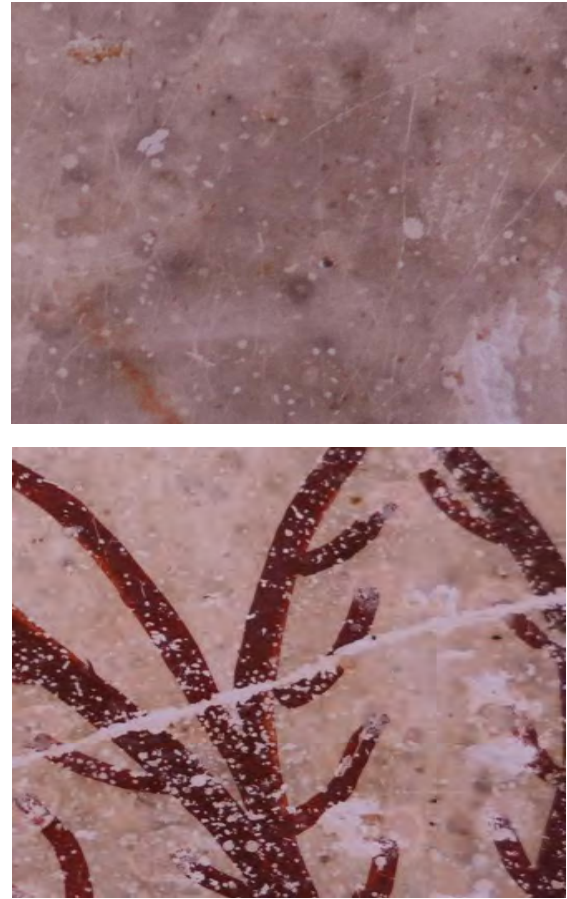
<p>GRI LEKELENMELER</p>	<p>GREY SPOTTING</p> <p>Faint, circular grey spots, 0.5-3 mm Ø, on the surface of the painting. Origin unclear, but often generally occurs in the same vicinity as the grey veil</p>

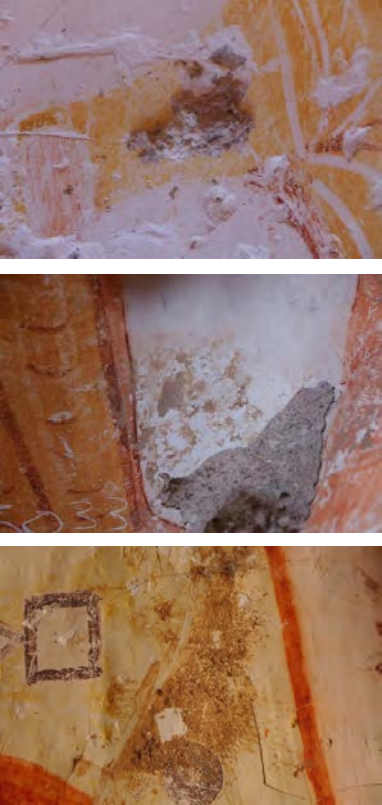
<p>YÜZEY BİRİKİNTİLERİ</p>	<p>SURFACE DEPOSITION</p> <p>Deposition of material on the surface of the painting, such as mud from birds' nests or from later construction in the church (ex. mud plaster)</p>

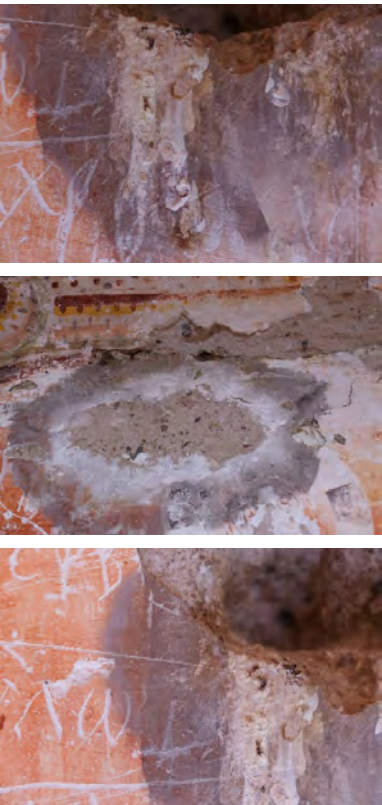
<p>BİYOLOJİK BOZULMA</p>	<p>BIOLOGIC DETERIORATION</p> <p>Discoloration (generally dark grey) of certain areas of painting due to animal inhabitation. Has also resulted in the peeling and detachment of the plaster layer in certain areas</p>

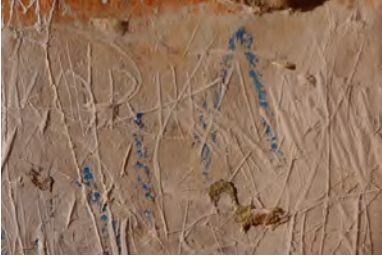
<p>YÜZEYSEL GRAFİTİ</p>	<p>SUPERFICIAL GRAFFITI</p> <p>Graffiti applied to the surface of the painting using a medium such as paint, ink, or graphite. At times the original paint layer used as a medium by taking advantage of its friability/water sensitivity</p>
